Volkswagen Lupo

Excessively high engine temperature, engine overheating. Water pump with plastic impeller.

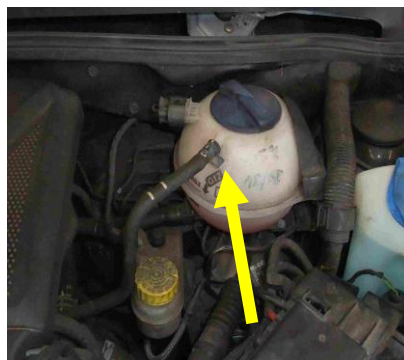
Figure 1.

Also remove the coolant return pipe from the
coolant expansion vessel (see figure 1.).
If no coolant flow is detected, the water pump is
to be renewed.

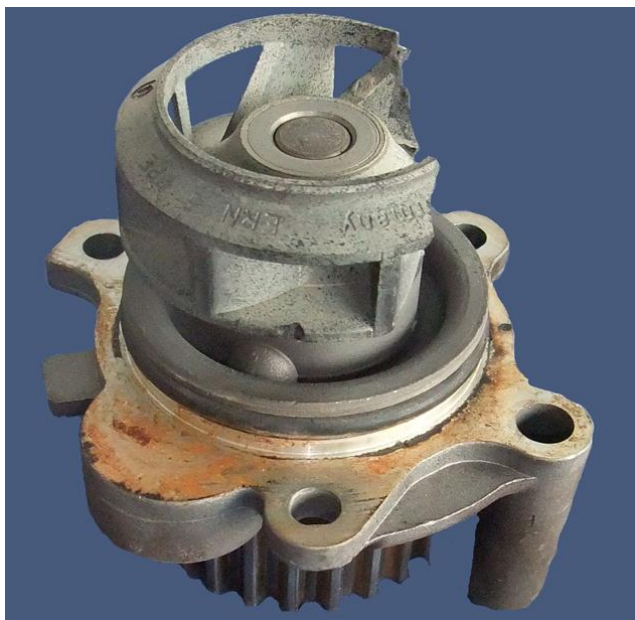
Figure 2.

This problem may be caused by a broken impeller (plastic
impeller, see figure 2+3) in the water pump.
