VW Passat **Type: 3B2 | 3B5** **Model year: up to 03/1998**

Coolant temperature warning light flashes

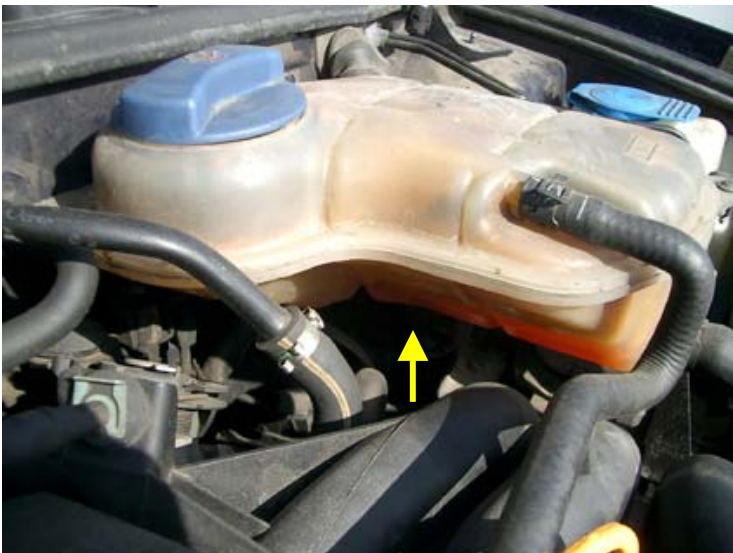
In the case of the above-mentioned vehicles, the formation of a coating on the sensor pins of the coolant level sensor can give rise to the coolant temperature warning light flashing even though there is sufficient coolant in the expansion tank. Due to the coating on the sensor pins, faulty measurements occur. The sensor is located below the expansion tank (see picture), and cannot be replaced separately. An attempt can be made to remove the coating on the sensor pins by flushing the expansion tank. Otherwise, the expansion tank must be replaced. From 03/1998, expansion tanks with a modified sensor are fitted at the factory.
