VW Polo (9N)

All vehicles with 1.9/74 KW pump-jet engine

Replacement of the coolant pump

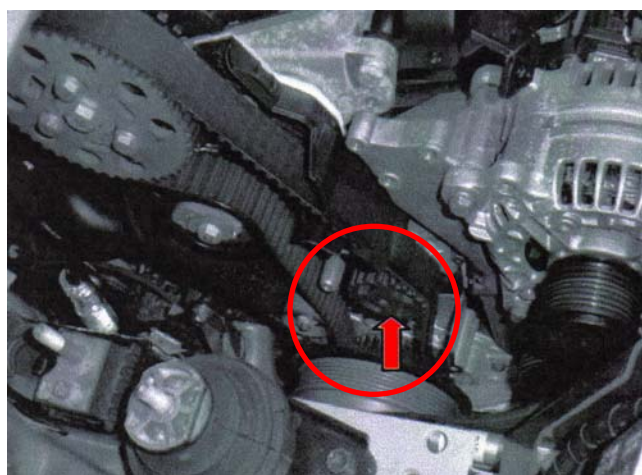
Fig. 1

In the case of some of the above-mentioned vehicles, an incorrect water pump was fitted at the factory. The fitment of an incorrect gear on the pump means that there is the possibility of the belt jumping. These vehicles should therefore be checked for this, such as during a service, for example. The fact that a check has already been made can be seen from the sticker with the inscription "19D5" (see Fig. 1), in the area of the spare tyre well. If the sticker is not present, proceed as follows:

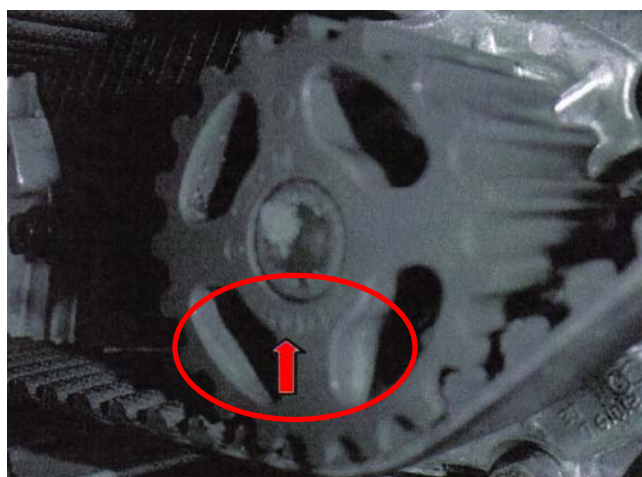
Fig. 2

- Remove the timing-belt cover.
- Turn the belt drive until the part number on the face of the gear can be seen (see Fig. 2).

Correct number: 038 121 031F

Incorrect number: 038 121 031G

- If the gear with the correct number is fitted, the vehicle can be reassembled.
- If the wrong gear is fitted, replace the coolant pump and the timing belt.
- After the repair, the sticker should be affixed in the spare tyre well. The sticker can be obtained via the
