## **VW**

### **Polo (6N1)**

### **Engine: AEX**

#### **Engine overheated**

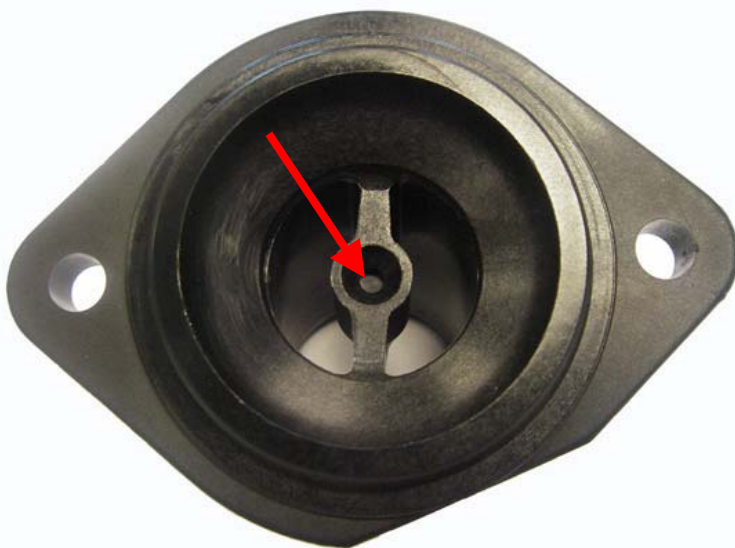
If, in the case of the above-mentioned vehicles, the coolant becomes too hot or the engine overheats, the cause may be a broken thermostat guide in the thermostat housing cover. The pressure pin of the thermostat normally supports itself against the centring in the cover of the thermostat housing (see photo). However, the centring can break, such that the pressure pin is no longer supported. As a result of this, the thermostat remains closed, which can then lead to overheating.

If there are complaints with these vehicles about the engine temperature, not only does the thermostat have to be replaced but also the housing cover must be examined and, if necessary, replaced as well.
