# BULLETIN

## VW Sharan (7M6 / 7M9) Model year: 2000 – 2010 Engine: AUY 1.9 TDI

### Engine warning light illuminates

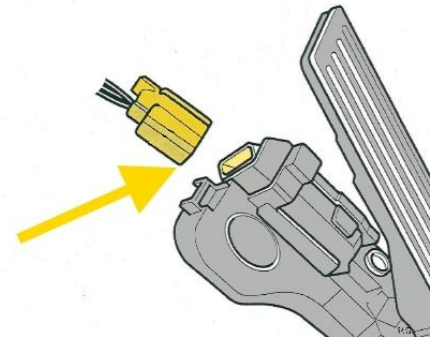
Figure 1

The error codes listed above all refer to an issue in the area of the accelerator pedal sensor (figure 1).

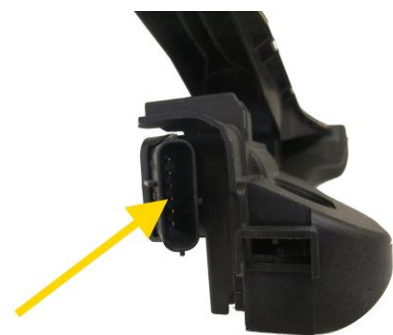
Figure 2

In this case, insufficient contact in the connection between the accelerator pedal sensor and the connector (figure 2) is responsible for the above-mentioned problem.

- Check the plug-type connection for damaged or corroded connector pins (figure 2, figure 3) and replace if necessary  
Spare parts:
  - Single cable: 000 979 025 EA
  - Crimp connector: 000 979 940
- Check that the accelerator pedal sensor is functioning correctly (carry out a noise or potentiometer test using an oscilloscope) and replace if necessary.
