## *VW Transporter T4 from 9/95 TDI Diesel Engine Motor Code: ACV*

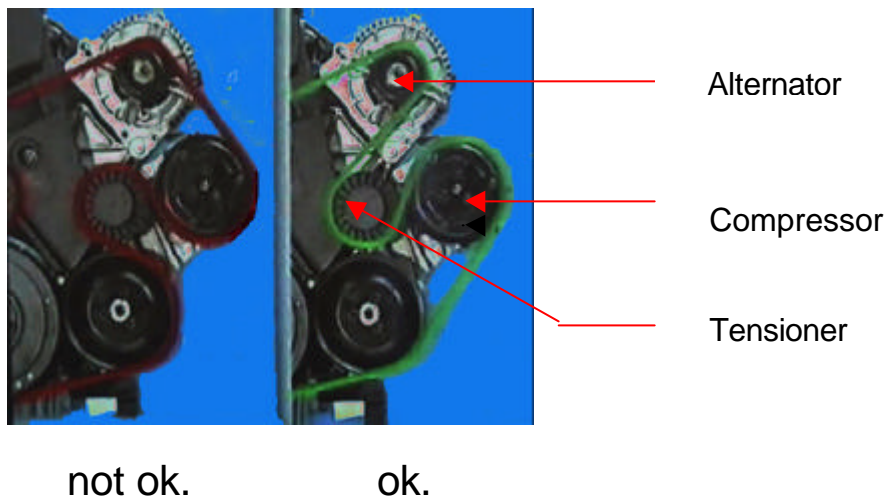
On vehicles with a 75KW TDI diesel engine, the poly-V-belt was sometimes not correctly fitted (see picture). This makes itself noticeable by squealing when starting, accelerating and stopping the engine. If the above happens then the belt-run should be checked and if necessary changed. The belt may also require renewing. It must run from the alternator over the tensioner pulley to the compressor.
