# INA GearBox

## Diagnosis of the twin-bearing assembly - 02T transmission VAG

Manufacturer: Volkswagen

Transmission type: 02T

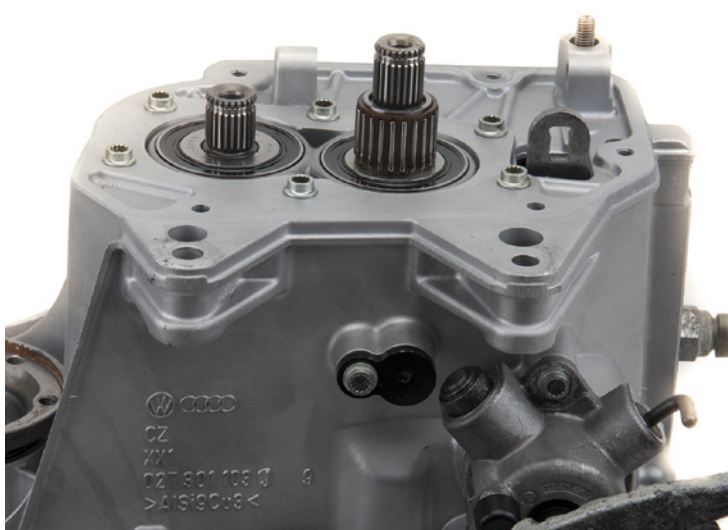
The two transmission shaft bearings shown in the figure are known as „eyeglass bearings“ due to their side-by-side arrangement together in a single mounting plate.

A defective twin-bearing mounting plate assembly shows no sign of damage on the outside. It usually makes a slight noise, (e.g. whirring, rattling or grinding) whilst the transmission still operates perfectly.

Twin-bearing mounting plate assembly and needle bearings of a 02T transmission

The increased friction in a defective twin-bearing mounting plate assembly generates excess heat. This can destroy the needle bearing of the positioned 5th gear, and the gear can no longer be engaged. The same thing can happen if there is not enough oil available at the 5th gear. In both cases, the cage is damaged and the needles scatter around the shaft.

1. Operate the transmission until it is warmed up.
2. With the clutch engaged and the transmission in neutral, increase the engine speed to approximately 4000 rpm.
3. Step on the clutch pedal and shut the engine off at the same time.
4. If you hear rattling noises which change as the speed of the transmission input shaft slows, the twin-bearing mounting plate assembly is defective.
