SERVICE-INFO

Overrunning Alternator Pulley related failures

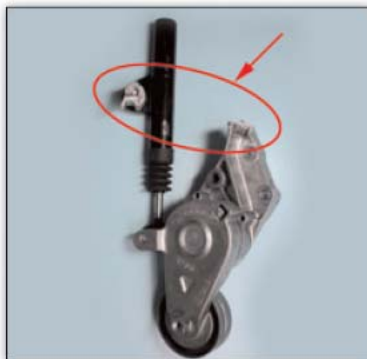
Excessive vibration causing housing to break.

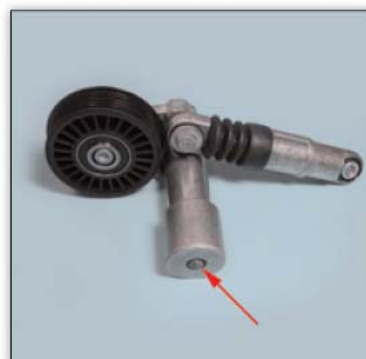
Bolt broken due to excessive side load.

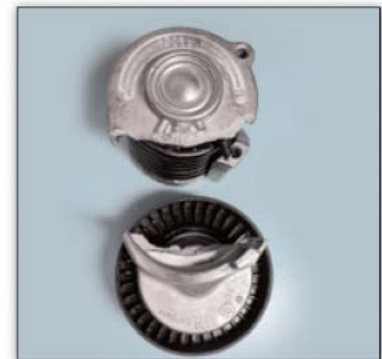
Excessive vibration causing housing to break.

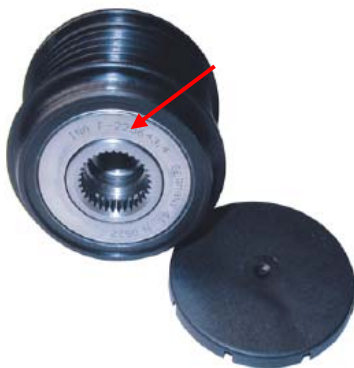
Many vehicle applications use more than one alternator, the easiest way to correctly identify the OAP required is to cross reference the number highlighted on the end of the pulley. A special tool, a torx with locking piece is required to remove OAP's
