Service Info

Assembly instructions

LuK RepSet® 618 3003 00

Manufacturer: Citroën, Peugeot

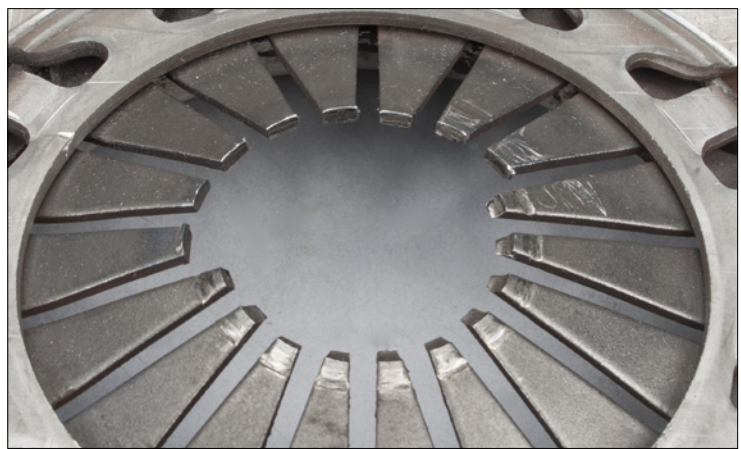
Figure 1: Faulty diaphragm spring caused by lack of preload

Due to incorrect setting or a mechanical fault in the clutch actuation system, the required preload is not always reached, causing a difference in speed between the clutch release bearing and the clutch. The resulting friction causes material abrasion on the diaphragm spring. As a result, individual tips of the diaphragm spring may break off and cause the clutch to fail.

Similar damage can also be caused by bearing misalignment due to missing or damaged gearbox dowels, worn cross shaft bushes or damaged / bent release fork.

For this reason, when replacing the clutch, the entire clutch actuation must be checked for wear and set according to the manufacturer's specifications.
