## Service Info

# Clutch grabs when shunting

Manufacturer: Mercedes-Benz

Models: Actros MP 2 (2003 - 2008)  
Actros MP 3 (2008 - )

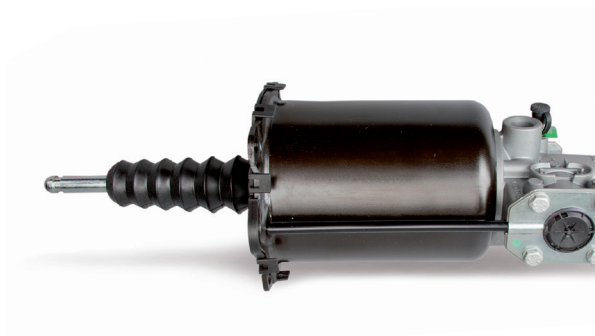
Image 1: The part number of the clutch booster must be checked

In the models listed above, the clutch may grab during shunting. The malfunction can be caused by inaccurate clutch regulation or an obsolete clutch booster. The following procedure is recommended for a professional repair:

- Replace the clutch booster with part no.: 000 250 0062 with part no.: 000 250 0562.  
Replace Wabco part no.: 9701500020 with part no.: 9701500010
- Check the setting of the clutch booster ram (see SI 0054) and adjust if necessary

- Put the transmission control in 'learn mode' in accordance with the specifications provided by the vehicle manufacturer
- If a dual disc clutch has been installed, the setting of parameter 1 in the transmission control and the clutch wear in parameter 3 must be corrected according to the specifications provided by the vehicle manufacturer

If the malfunction persists after all measures have been implemented, the clutch must be replaced.
