FORD TRANSIT 2.4 Di 2000 ❖❖❖

Starter Motor issues

LuK 0511
Amended: 21.03.2012
Subject to technical changes
© 2012 Schaeffler

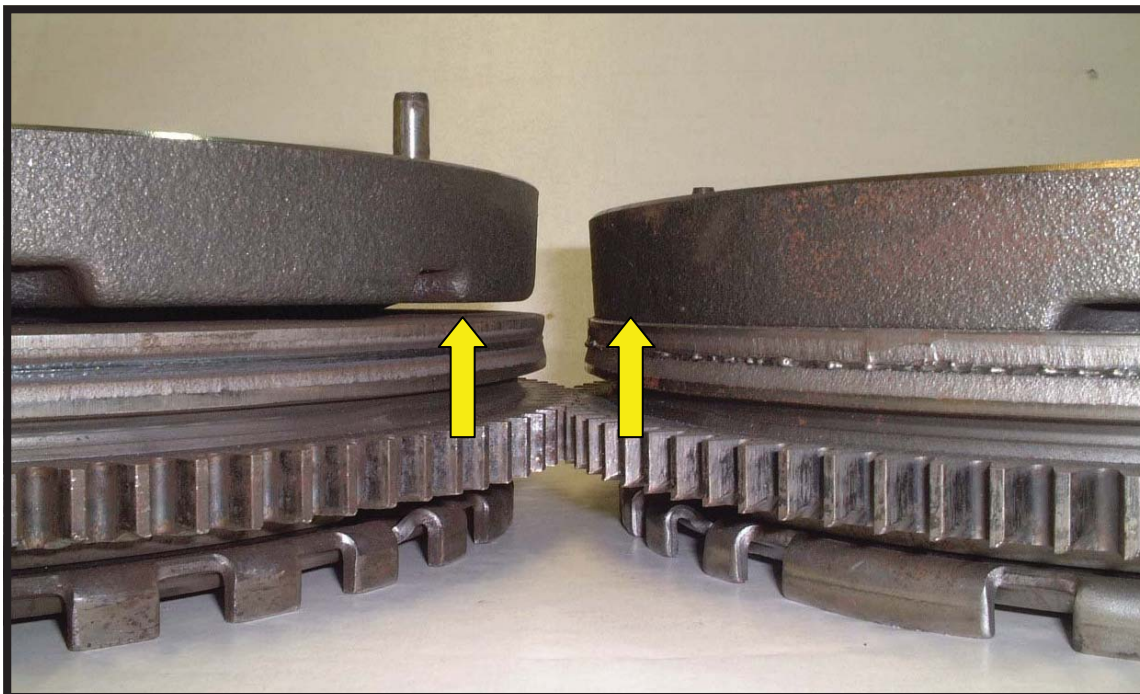
If the DMF excessively wears, the two masses can begin to make contact as shown on the right hand of the image below. This can cause a build up of dust or swarf in the bellhousing. Due to the design and mounting of the starter motor it can become contaminated if the residue is not removed. The swarf from the worn flywheel can cause premature wear to the starter gear and be drawn into the magnets, damaging the armature itself.

If the starter motor is being replaced and excessive wear can be seen on the gear and shaft, it is recommended that the DMF is checked at the same time.
