## Service Info

# Grabbing clutch

**Possibly caused by incorrect adjustment of the clutch booster**

**Modelos:** Actros MP 2 (2003 -2008)  
Actros MP 3 (2008 - )

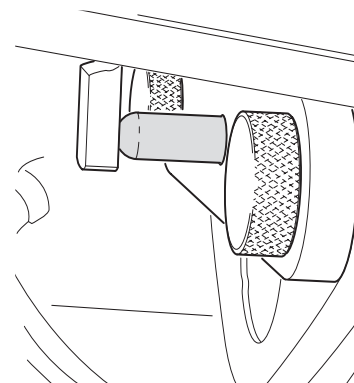
In the vehicles listed above, is possible for the clutch to grab in a variety of driving situations. This may be due to the inaccurate setting of the clutch booster.

Image 1: The ram of the clutch booster can be adjusted

In the event of a complaint, the setting of the ram of the clutch booster must be checked first. This can be done using an adjustment device from the vehicle manufacturer.
