Issue no. 4/2014: Turbo tip—excessive crankcase pressure in vehicles with turbochargers 030TC14011000 or 082TC15850000

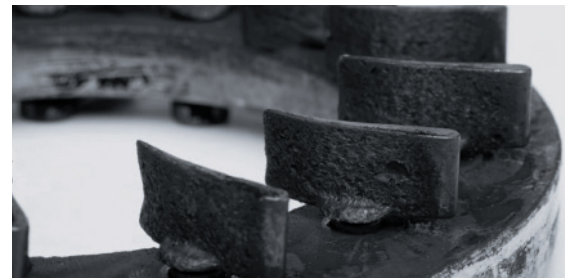
VTG: heavy oil carbon build-up blocking the mechanism

These problems cannot be resolved by merely replacing the turbocharger. The cause needs to be found and eliminated. In general, we recommend to systematically replace the oil mist separator along with the turbocharger.
