Issue No.: 1/2013 – Installing the water level sensor in diesel fuel filters KL418, KL431, KL581

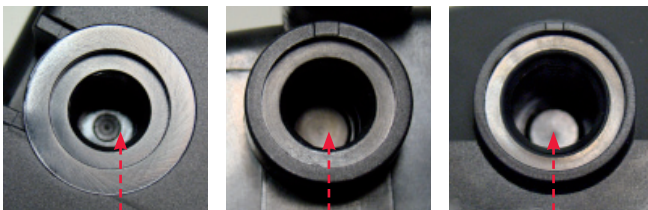
Figure 1: KL418 Figure 2: KL431 Figure 3: KL581

Some fuel filters with a plastic housing are equipped with an interface for fitting a water level sensor. This sensor is not installed in all vehicles. When the filter is new the threaded mounting hole has a visible, thin dividing wall at the end and appears closed.

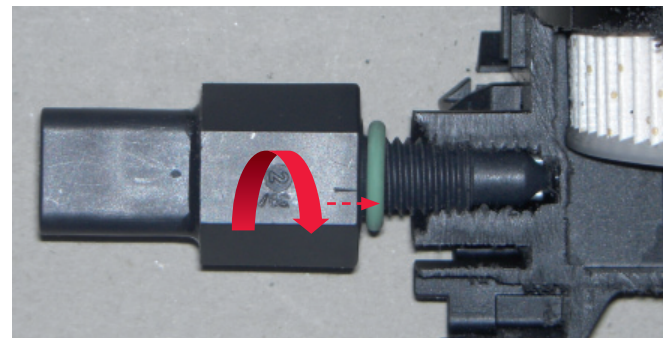
When screwing the sensor into place, considerable resistance can be felt and the sensor head penetrates the dividing wall in the filter at a predetermined breaking point. This causes a cracking noise.

This noise and the resistance are not indicative of a fault: neither the sensor nor the filter are damaged during the installation process. The dividing wall that has broken off does not pass through the filter element: it remains on the filter's dirty side. This ensures that all components maintain their full functionality.

Figure 4: The water level sensor penetrates the dividing wall in the filter when being screwed into the inline fuel filter and causes a cracking noise.
