### Issue no. 04/2017: Leakage after fitting the oil filter insert OX 388D Eco in 1.6 and 2.0 TDI engines

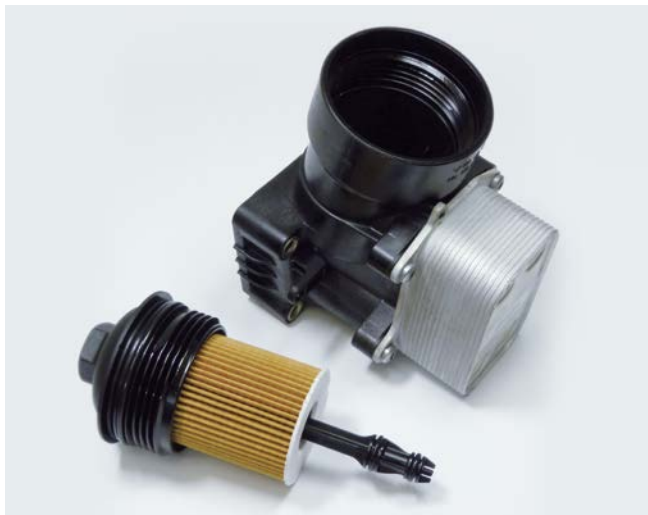
Figure 1: Oil filter module with oil filter insert OX 388D ECO

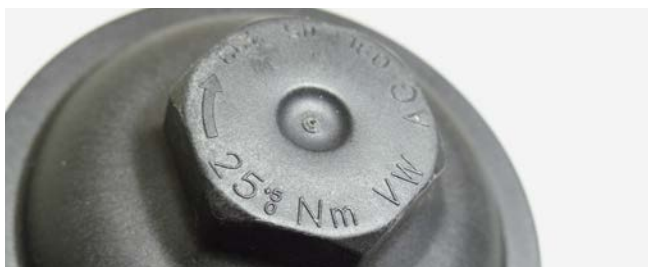
Figure 2: Torque specification on the housing cover

After the oil filter insert is changed, the cover is screwed back onto the housing; the permissible torque is **25 Nm** (+5 Nm).

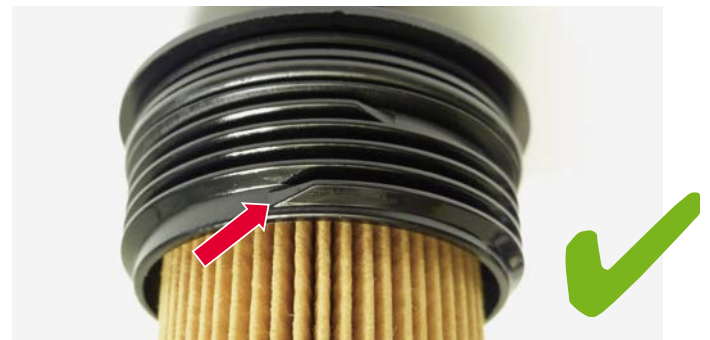
Figure 3: Undamaged thread

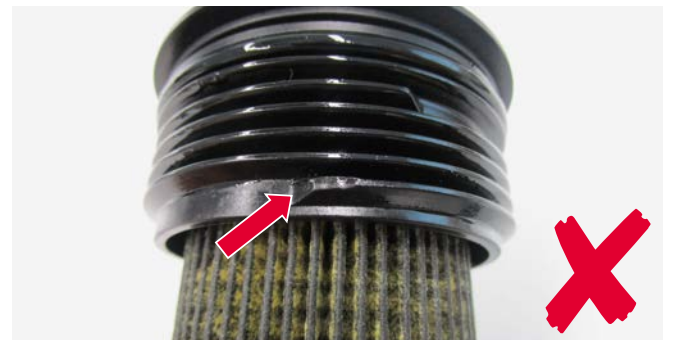
If too much force is applied, this can damage the thread and warp the cover, resulting in leakage from the housing cover and loss of engine oil.

Figure 4: Damaged thread

**Important!** When changing the filter, always use a torque spanner to ensure compliance with the manufacturer's specifications. To prevent damage, coat the new gaskets with clean engine oil before fitting.
