DAMAGED DIAGNOSIS

VALVES

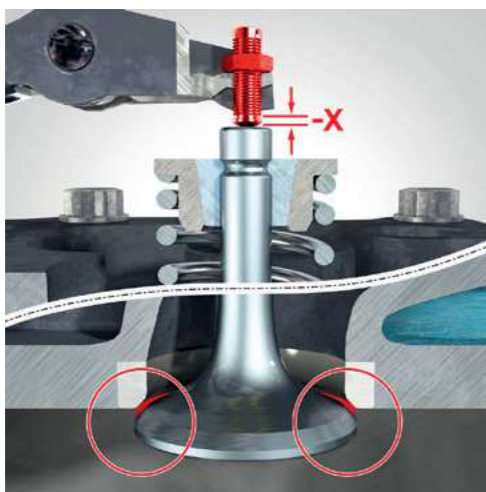
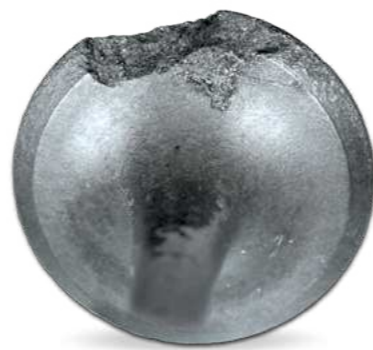
Incorrect valve clearance settings

Cause:
The valve clearance has been set too tight or the maintenance intervals have been exceeded.

Consequence:
The valve no longer closes properly. Combustion gases flow past the valve seat and heat up the valve head. This causes the valve head to overheat and burns through in the seat area.

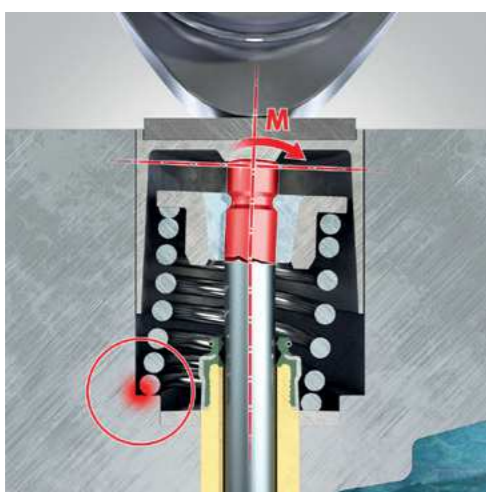
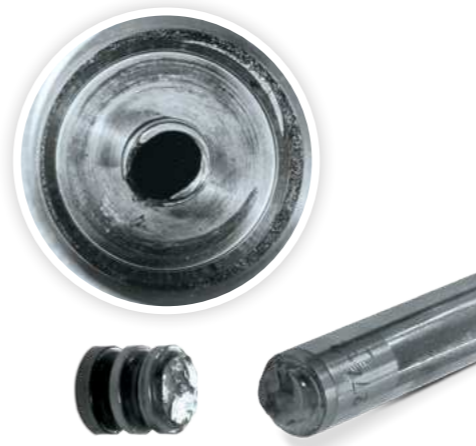
Incorrectly installed valve springs

Cause:
The spring was not inserted correctly during installation. The tilted spring has caused a lateral bending moment (M) on the valve stem.

Consequence:
The resultant alternating bending stress ultimately caused a fracture of the valve stem face and destroyed the valve guide.

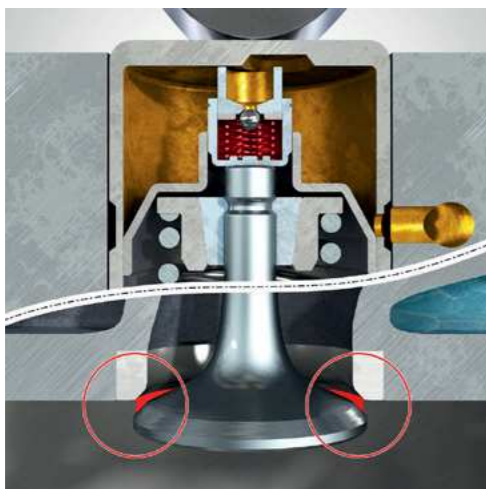
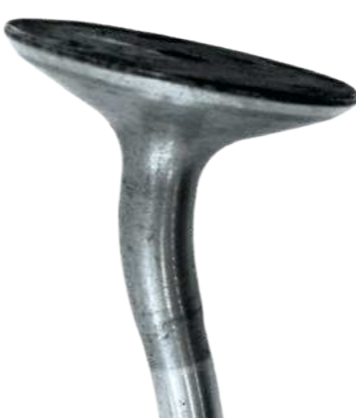
Incorrectly installed hydraulic tappets

Cause:
After installation of the tappets, the minimum required waiting time before starting the engine (at least 30 mins) was not observed. As a result, the excess oil in the working area of the tappets did not have enough time to escape.

Consequence:
If the engine is started prematurely, the valves strike against the piston and can bend or break.

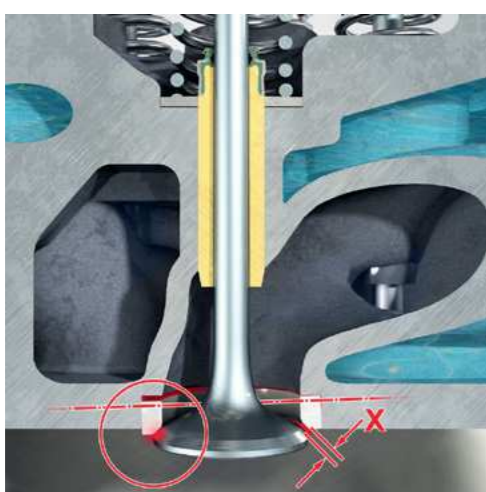
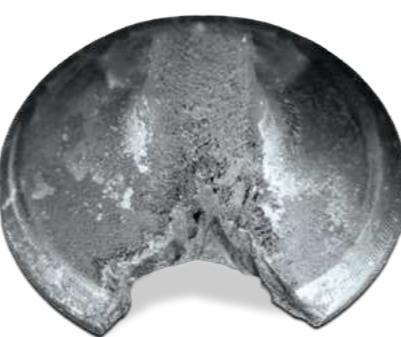
Misalignment at the valve seat insert or valve guide

Cause:
Non-centric remachining of the valve seat or guide.

Consequence:
The valve fails to close properly, overheats and burns through in the seat area. Fatigue fractures in the area of the fillet may also occur as a result of the unilateral stress of the valve head.

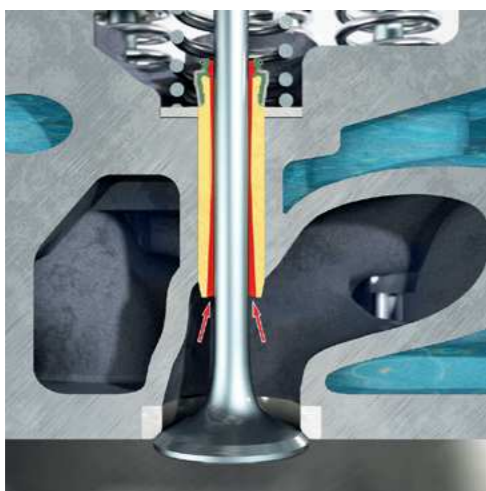
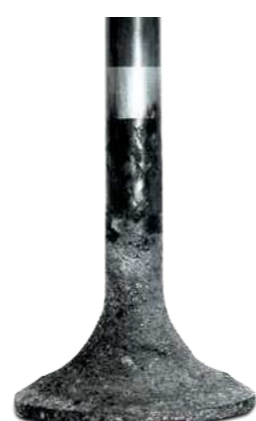
Excessive valve guide clearance

Cause:
The valve guide clearance is too large due to excessive wear of the valve guides or due to excessive reaming during repair.

Consequence:
The influx of hot gases can cause significant carbon deposits in the area of the stem guide. The valve becomes stiff and fails to close properly, with overheating of the seat occurring as a result (burns or shot channels).

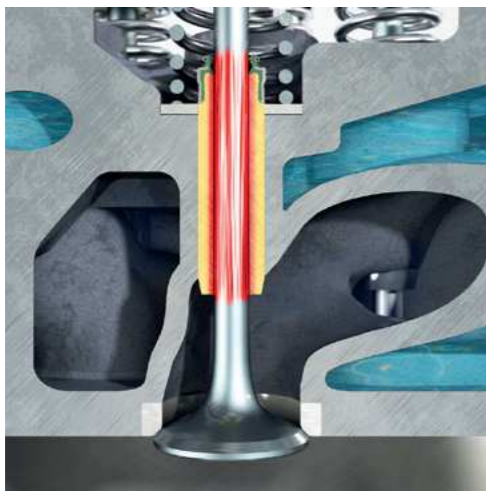
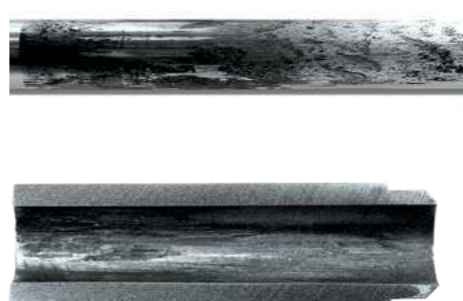
Insufficient valve guide clearance

Cause:
The guide diameter has been dimensioned too small during replacement of the valve guides.

Consequence:
Inadequate lubrication, stiffness and seizures of the valve stem in the guide. Consequential damage such as overheating of the valve head or seat area can occur.

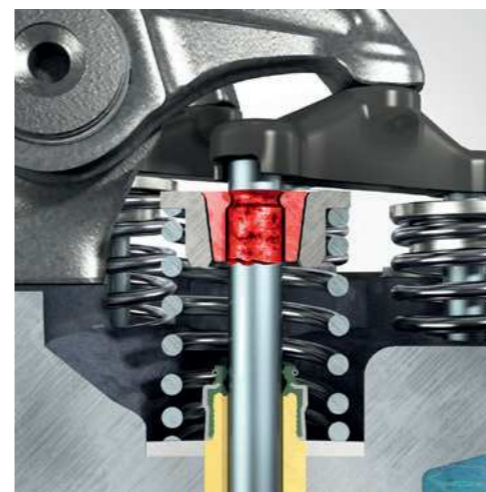
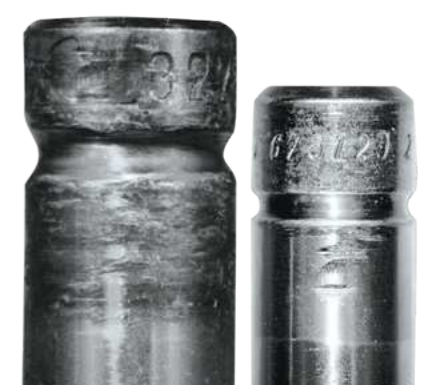
Use of worn valve cotters

Cause:
Old, worn valve cotters were used during replacement of the valves.

Consequence:
If worn valve cotters are reused, the clamping system can become loose during operation. This results in frictional corrosion on the stem and weakening of the valve in this area. This can cause vibration fatigue failure.

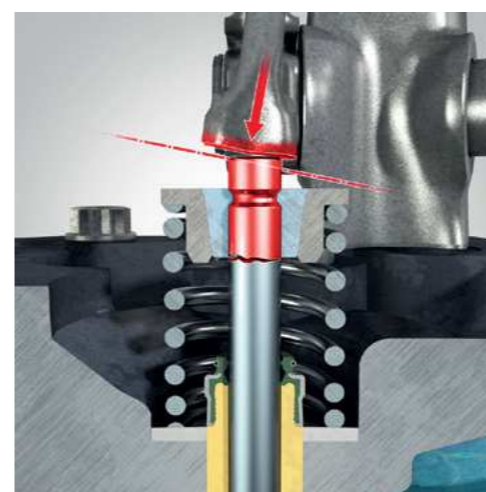
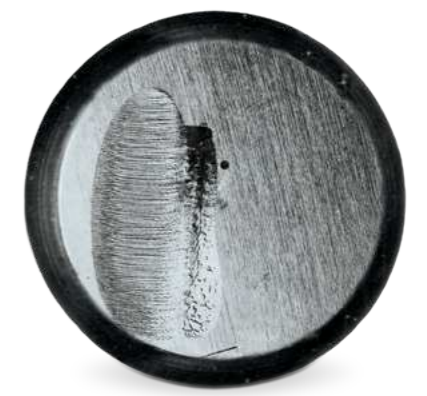
Installing damaged rocker arms/finger type rockers

Cause:
Forces are applied eccentrically from the rocker arm to the skirt end face of the valve.

Consequence:
Unilateral wear occurs on the stem and the skirt end. The lateral force on the valve stem caused by the eccentric application of force causes fatigue fractures in the area of the clamping system.

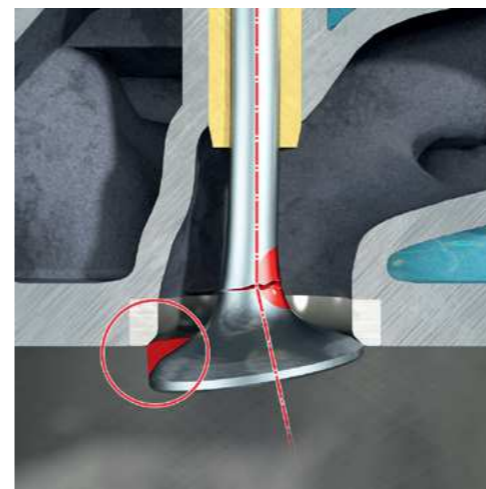
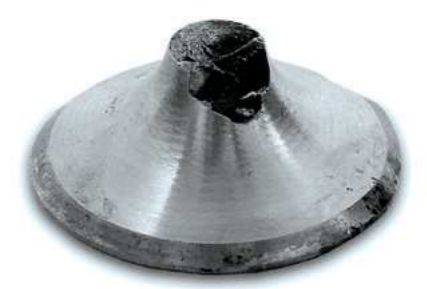
Installing bent valves

Cause:
A bent valve stem will cause unilateral support of the valve seat on the seating ring.

Consequence:
The unilateral stress causes alternating bending stresses and fatigue fractures in the fillet radius at the transition to the stem.

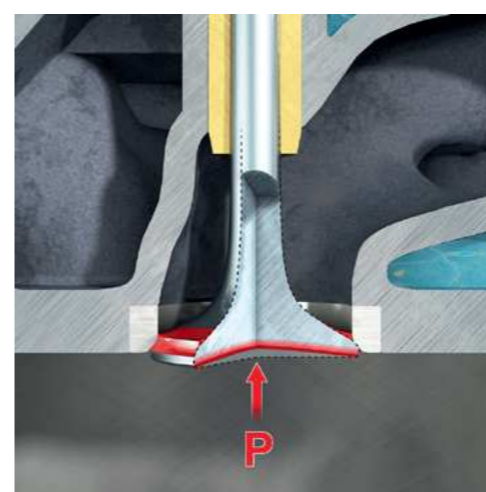
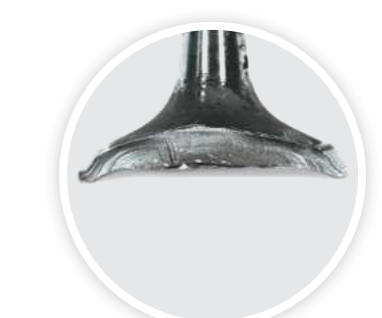
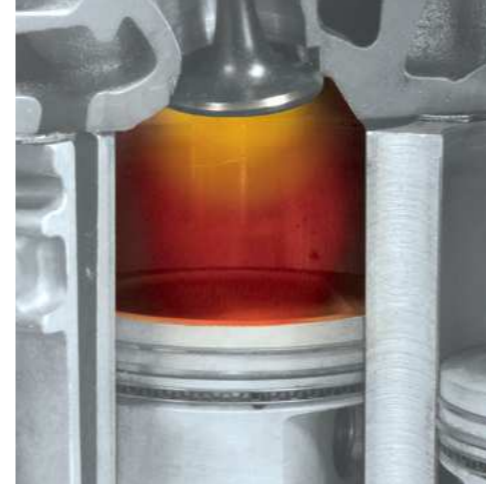
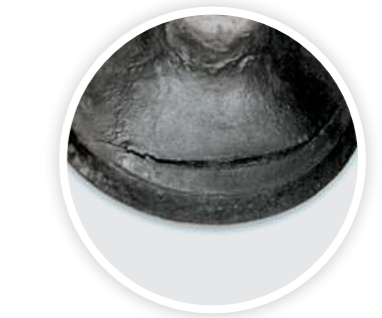
Valve overstressing due to combustion defaults

Cause:
Significant increased pressure and temperature loads occur in the combustion chamber as a result of combustion defaults.

Consequence:
The valve head cannot withstand the high thermo-mechanical loads and bends inwards. This results in so-called tulip formation and causes fractures in the area of the valve head.
