# Mercedes-Benz W211 variable intake manifold

## Fracture on cam control mechanism

Vehicles:	Product: Variable intake manifold		
Mercedes-Benz	PIERBURG no.	Ref. no. *	Replacement for *
C, CLC, CLK, CLS, E, ML, R, S, SL, SLK, Sprinter, Viano	<b>7.00246.33.0</b>	A 272 140 21 01 A 272 140 22 01 A 272 140 24 01	7.00246.26.0 ... .29.0

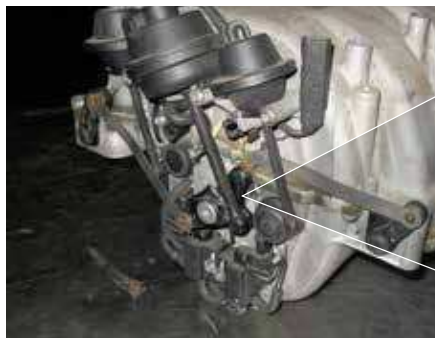
If oil leaks out here and drips onto the cam control mechanism, its plastic material can become porous and break.

*Damage symptoms: Fracture on cam control mechanism*

- If oil leaks out, the plastic line must be replaced immediately with an aluminium line.
- If the cam control mechanism is already damaged, the intake manifold should be replaced.

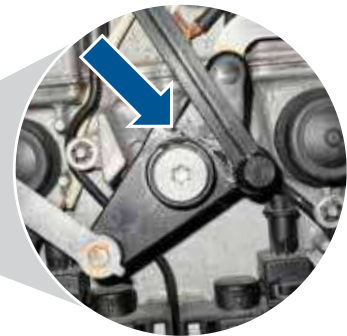
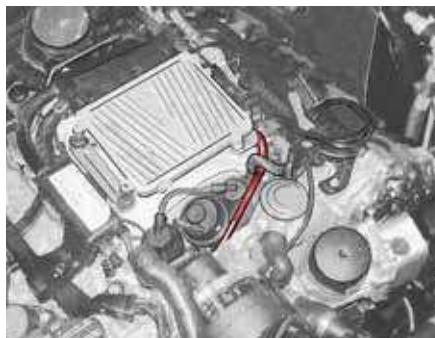
The cause of the damage is not the intake manifold but a leaky line in the engine ventilation system. The line in the engine ventilation system runs above the cam control mechanism on the intake manifold. The line originally fitted in the engine ventilation system can start to leak with age or load.

*Engine compartment W211 with engine ventilation system line (highlighted)*

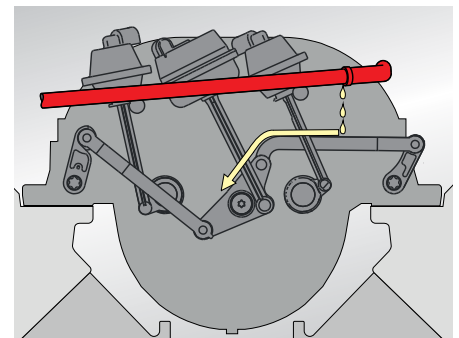
*Cause of damage: Oil leaking from line of engine ventilation system (highlighted) and damaging cam control mechanism*
