# Intake manifold/electric drive module

Possible fault cause and replacement

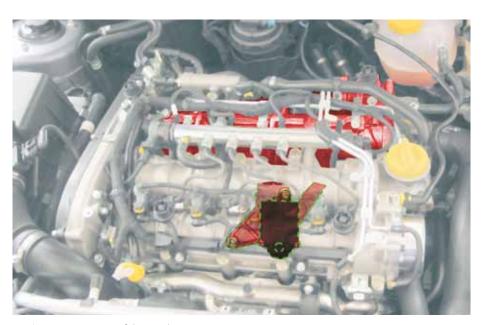
Engine compartment of the Opel Vectra: The intake manifold with the EGR flap is emphasised in red. The drive module is located, not being visible, "behind the engine" and is only hinted (green dashed line).

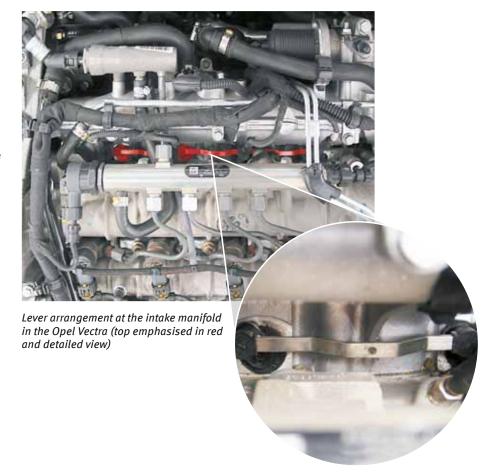
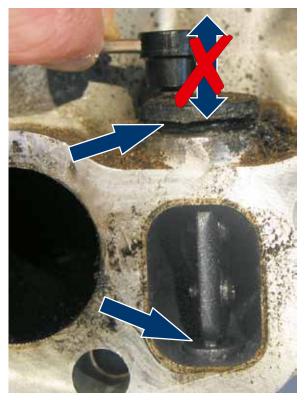
The true fault cause are often worn out, tight tumble flaps in the intake manifold. The drive module can no longer move the tight tumble flaps and indicates an error.

The cause for these malfunctions are often stiff or sticking tumble flaps.

Deposits or sticking tumble flaps can be caused by very oily intake or charging air. There are many reasons for this.

Worn out bearings at the tumble flaps

When the faulty intake manifold remains in the vehicle and only the drive module is changed, this error will reappear quite quickly.

- Perform an actuator diagnosis (according to manufacturer's information for the diagnosis unit) of the drive module: if the drive module switches, power supply and drive module are electrically in order.
- Check to ensure that there is a proper link ("lever arrangement") between the drive module and the tumble flaps.
- Check to ensure that the tumble flaps can move freely. The actuating lever must, after being deflected, return to its initial position within a period of 1 to 2 seconds.
- It must not be possible to move the tumble flaps in the axial direction (see figure).
