Oil Circuit Pressurizing Procedure

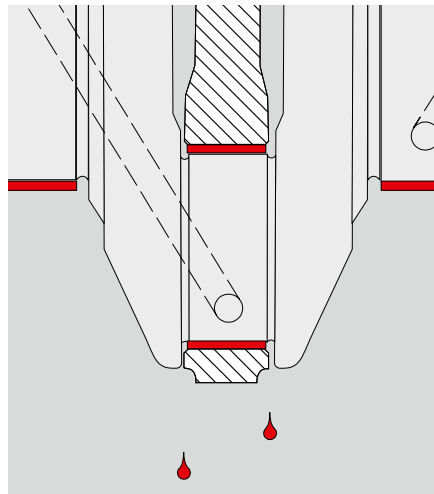
Fig. 3

If a plain bearing is intact, a few drops of oil will leak out (Fig. 3), while a faulty plain bearing will have a far greater oil leakage or no leakage at all. If too much oil escapes from one plain bearing in comparison to the others (Fig. 4), it can be assumed that the bearing clearance is too big. Possible causes are the installation of wrong plain bearing shells or a bearing journal that was ground too small or is worn. No oil escape, on the other hand, points to incorrectly seated bearing shells or clogged oil channels. Here in any case the cause must be eliminated and the pressure application process repeated. In the case of engines with piston spray cooling, the functioning of the oil spray nozzles and the direction in which they spray can also be checked.

To do this, the oil pan is removed and the oil escape of the crankshaft plain bearings is checked while pressure is being applied, as illustrated in Figures 3 and 4. Here, irregularities in the oil outflow will be noticed immediately.
