Rattling noises due to oil sludge in the vacuum pump

Vehicle	Product	Pierburg no.
VW Transporter LT, T4	Vacuum pump	7.22300.62.0/.69.0

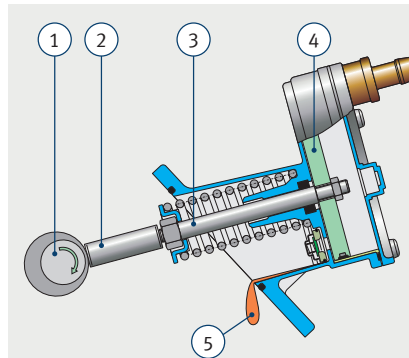
The piston vacuum pump is driven by the camshaft (1) through a connecting tappet (2). In the recommended installation position, the engine oil can flow back into the engine (Fig. 1). The installation position in the VW Transporter is as shown in Fig. 2.

Fig. 1:
Recommended installation position
1 Camshaft
2 Connecting tappet
3 Tappet

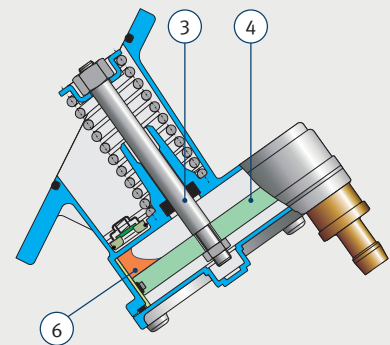
If oil is not changed regularly, the engine oil ages. Oil sludge with viscous consistency builds up between piston crown and housing. This prevents the piston from reaching its end position. There is leeway between tappet and connecting tappet. This results in rattling noises, which sound like bearing damage on the crankshaft.

Fig. 2:
Installation position VW LT and T4
4 Piston
5 Oil drainage
6 Oil collection

In case of oil sludge deposits the vacuum pump must be replaced. It cannot be cleaned, as the vacuum pump cannot be opened with ordinary tools and there are no spare parts.

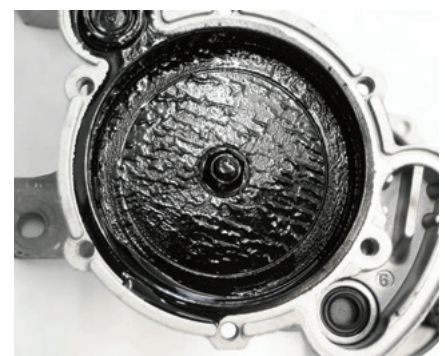
- Intervals for changing oil not adhered to
- Insufficient quality of engine oil
- Soot formation due to unclean combustion
- Faulty exhaust gas recirculation

Fig. 3: Oil sludge in the vacuum pump of the VW Transporter results in rattling noises
