## Skoda Felicia 1.3

### Complaint: motor stalls when running idle

Vehicle	Product: electromotive throttle body	
Skoda Felicia 1.3	PIERBURG No.	O.E. No.*
	7.22456.01.0	441.0.4301-416.6

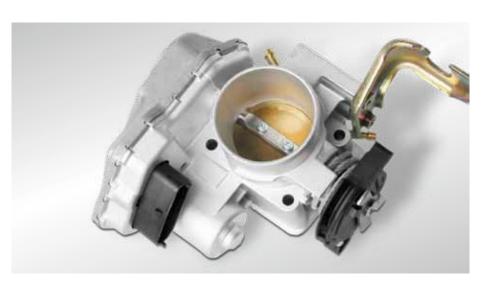
In the course of checks in the workshop it is found that the electromotive throttle body is contaminated.

Possible causes for the contamination at the throttle body can be:

- · Leaks in the intake tract
- Improper servicing, uncleanness when replacing the air filter or using incorrect air filters, for example
- Excessive escaping of oil from the crankcase
- Oil particles from oil-wetted racing air filters

Even after exchanging or cleaning a contaminated throttle body, the engine management system has in its memory still the "old, shifted" ignition data. Cleaning of the throttle body is not recommended by us: the throttle body may suffer damage.

After having replaced the throttle body, it is mandatory to match the engine management system to the throttle body, since otherwise the complaints persist!

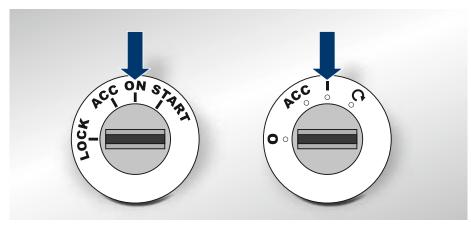
Position "1" for different ignition locks

Turn the ignition key from the zero or locked position to position 1 and maintain it in this position for 10 seconds.
