# Stem fractures on intake and exhaust valves

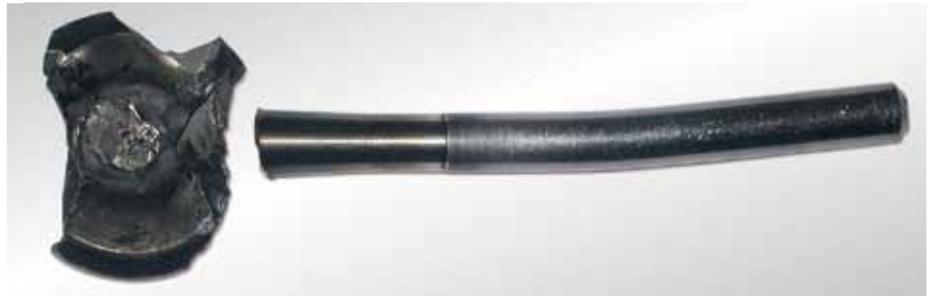
Fig. 1

cylinder head repair (the toothed belt had broken). A short time after the vehicle was on the road again, there was another damage of the valve train. On dismantling the engine, a valve was discovered that was broken on its valve stem end and valve head. An examination of the parts showed that the valve stem end has been broken first, namely in the area of the lower recess for the valve cotter. During further course of the damage, the valve fell into the combustion chamber where it collided with the piston and has been destroyed.

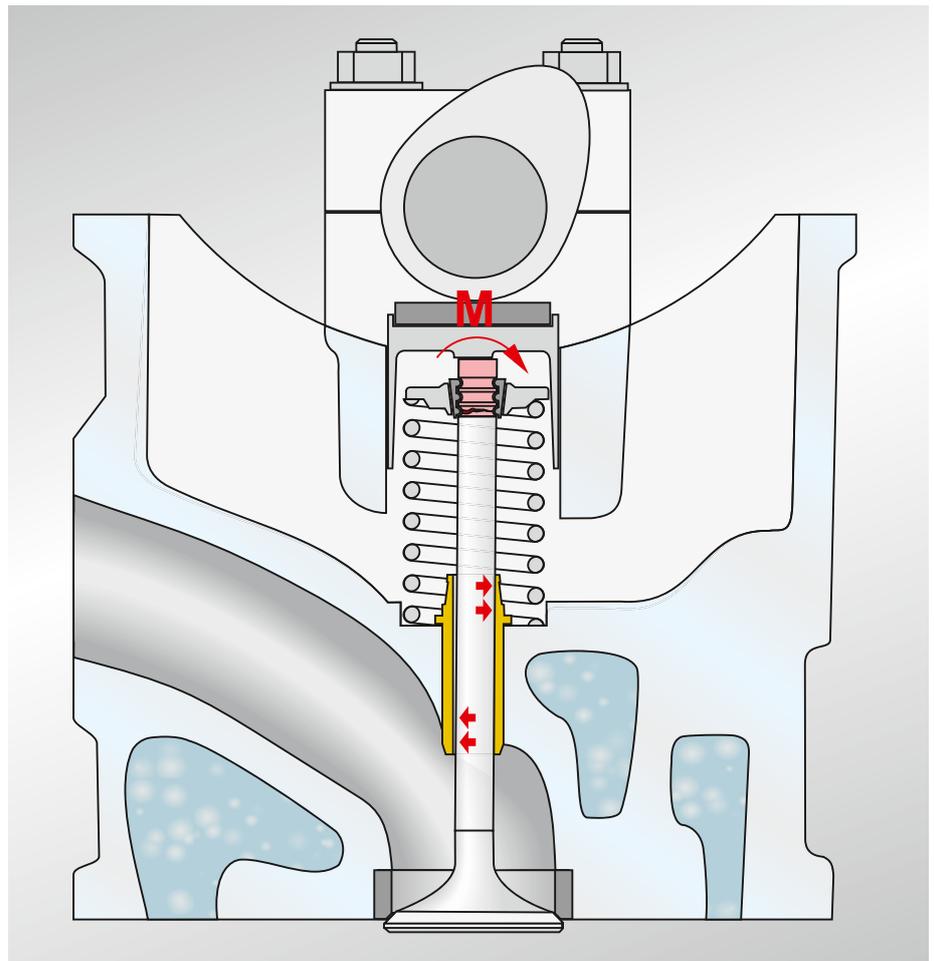
Fig. 5

Due to the short period of time between repair and occurrence of damage and the result of the material analysis, the damage was caused as follows: On inserting the valve, material from the valve guide settled in the lowest of the three cotter fastening grooves. Presumably the guide was not completely cleaned subsequent to machining or the material was scraped off by the valve during insertion. The foreign material became jammed in the recess while assembling the valve-spring resulting in a slant fit of the valve-spring retainer. In addition, the valve was hindered in its natural rotation. As a result of the slant position of the valve-spring retainer, a bending moment occurred on the valve stem end (Fig. 5) and result in the fracture of the valve in the lower fastening groove.

- ! **In order to avoid valve fractures, it is urgently recommended to pay attention to cleanliness and to also consistently replace the interacting sliding parts of the valves. In particular newer valves with valve stem diameters of 7 mm or less react sensitively to alignment errors and inaccuracies of shape. It is therefore also recommended always replacing valve cotters as well, any time the valves are changed.**

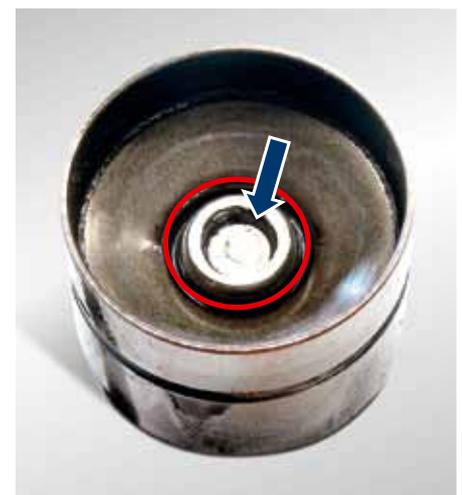
Fig. 6

If an open valve collides with the piston, as is frequently the case when the toothed belt breaks or skips, it is inevitable that one of the valve train components will deform due to a lack of clearance. In the worst case, the camshaft or its bearing support will break. More frequently, however, valves or hydraulic valve tappets are bent which react in an even more sensitive way due to smaller material thickness. Figure 6 shows a hydraulic

valve tappet which has been severely dented by the valve stem as a result of a toothed belt fracture on the working surface of the valve. Unfortunately, damage of this kind is often overlooked, especially if they are not very distinctive, and the tappets are reinstalled. It is then only a matter of minutes until the engine fails again after repair.

To avoid costly follow-up repairs, hydraulic valve tappets should be always replaced when repairing cylinder heads with a mileage of 120,000 or more.
