Electric EGR Valves (Renault, Opel)

Stickiness at the valves

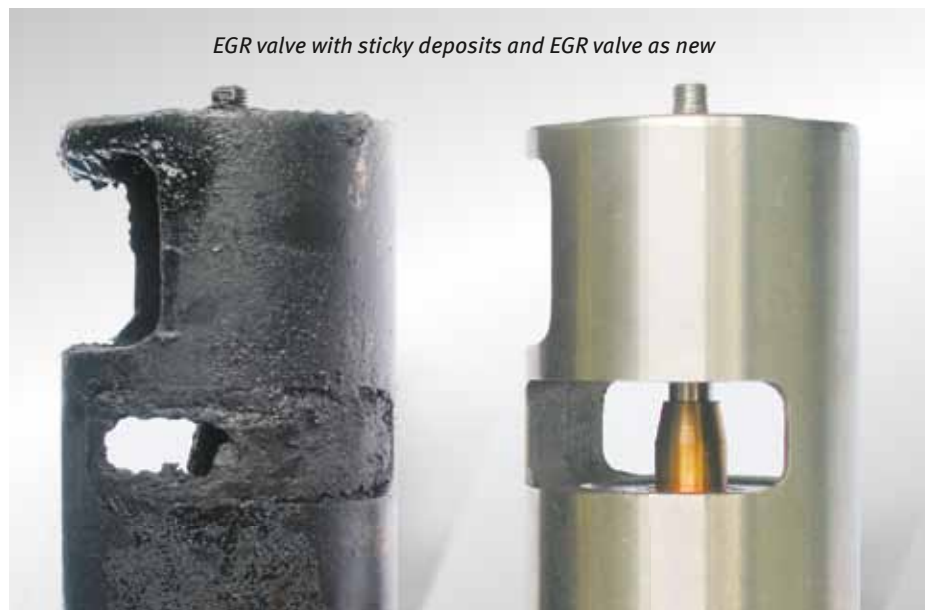
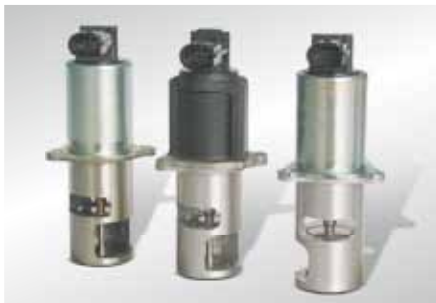
Product view (extract)

The built-in electrical EGR valves suffer through oil-containing deposits.

- The valve is stiff.
- The valve is stuck and does not open.
- Due to the deposits the opening cross-section is reduced.
- The valve does not close fully.

The causes can generally not be attributed to the EGR valve itself.

The EGR valve must be checked and replaced as required.

! We do not recommend cleaning the EGR valve; when doing so, it might be damaged.

In many cases an update for the controller software can remedy problems related to excessive stickiness.
