# Vacuum pump damage

## Insufficient lubrication due to incorrect assembly

Vehicle	Engine identification	Product: Vacuum pump
		PIERBURG No.
Peugeot, Citroën with 1.8/1.9 l Diesel engine	XUD7, XUD9A, XUD9AU, XUD9TE, XUD9Y, D9B	7.21174.90.0/.94.0/.95.0

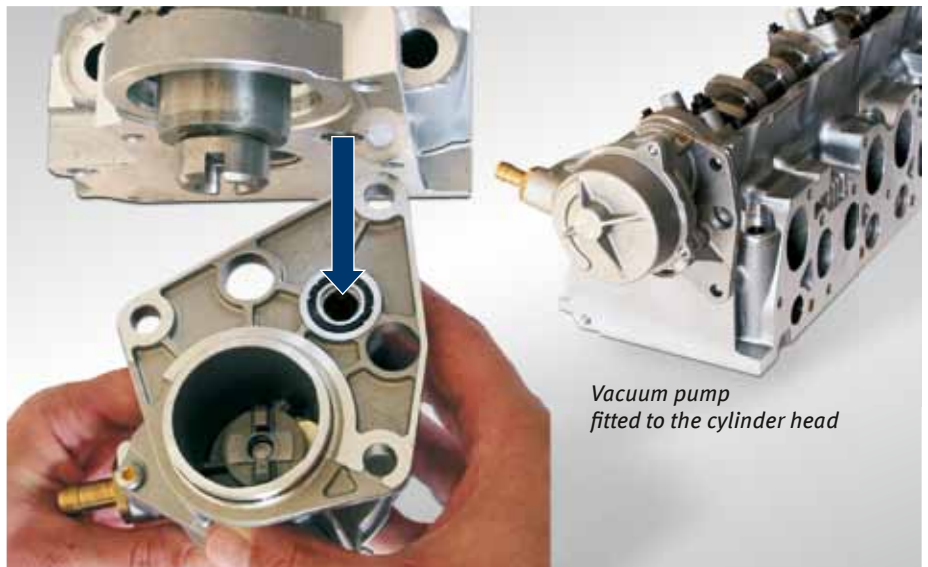
*Vacuum pump fitted to the cylinder head*

*Important: Proper lubricating oil supply to the vacuum pump*

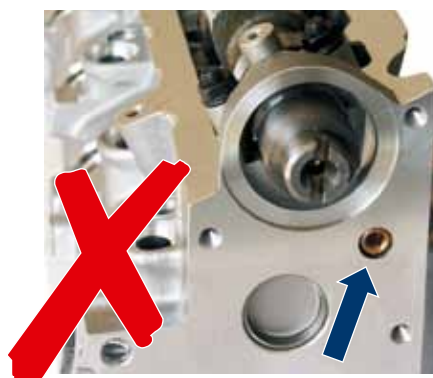
When replacing the cylinder head within the scope of an engine repair, the closure screw was not removed which seals off the opening of the lubricating oil supply to the vacuum pump.

**In the case of vacuum pumps which are driven by the camshaft, this closure screw must be removed from the cylinder head.**

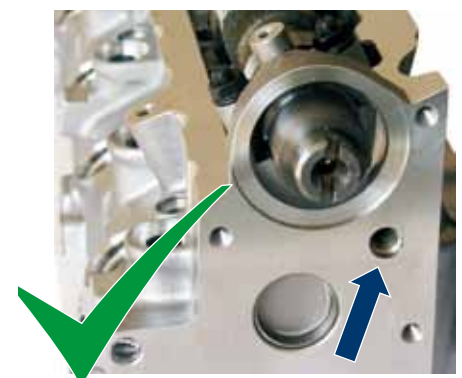
**If this is not done, the vacuum pump will suffer a total failure due to insufficient lubrication already when being operated for a short period of time.**
