Valve damage and causes

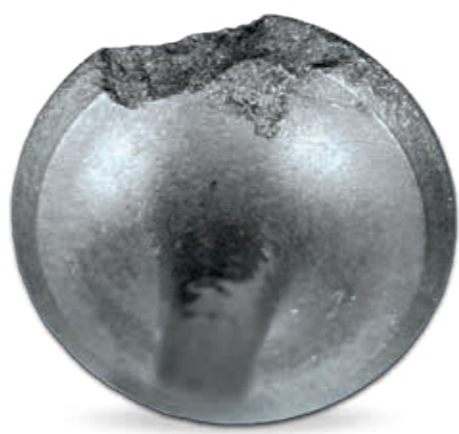
Incorrect valve clearance settings

Cause:
The valve clearance has been set too tight or the maintenance intervals have been exceeded.

Consequence:
The valve no longer closes properly. Combustion gases flow past the valve seat and heat up the valve head. This causes the valve head to overheat and burns through in the seat area.

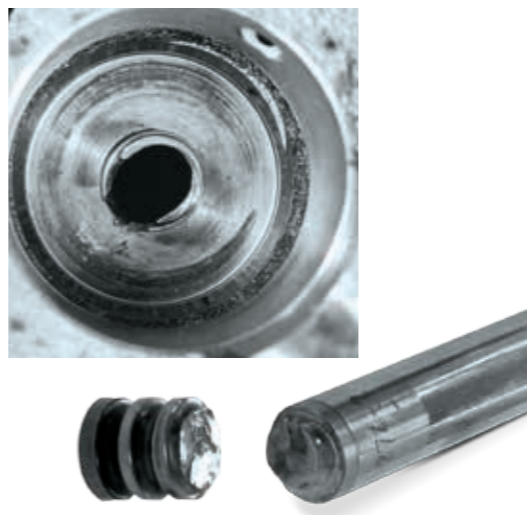
Incorrectly installed valve springs

Cause:
The spring was not inserted correctly during installation. The tilted spring has caused a lateral bending moment (M) on the valve stem.

Consequence:
The resultant alternating bending stress ultimately caused a fracture of the valve stem face and destroyed the valve guide.

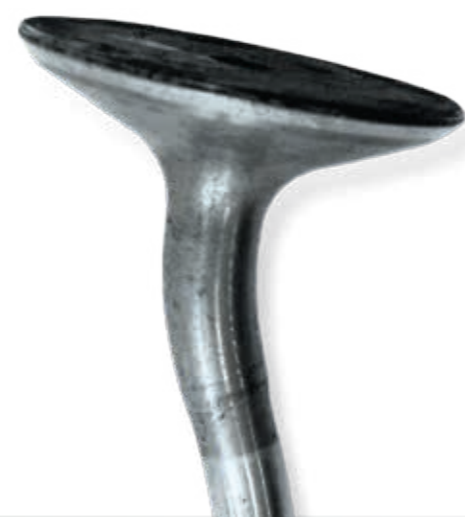
Incorrectly installed hydraulic tappets

Cause:
After installation of the tappets, the minimum required waiting time before starting the engine (at least 30 mins) was not observed. As a result, the excess oil in the working area of the tappets did not have enough time to escape.

Consequence:
If the engine is started prematurely, the valves strike against the piston and can bend or break.

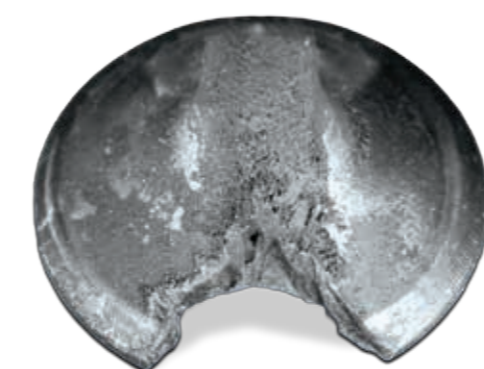
Misalignment at the valve seat insert or valve guide

Cause:
Non-centric remachining of the valve seat or guide.

Consequence:
The valve fails to close properly, overheats and burns through in the seat area. Fatigue fractures in the area of the fillet may also occur as a result of the unilateral stress of the valve head.

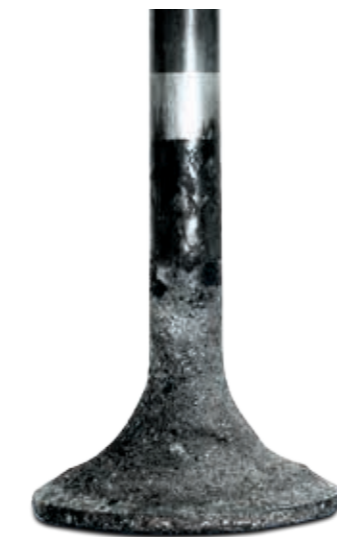
Excessive valve guide clearance

Cause:
The valve guide clearance is too large due to excessive wear of the valve guides or due to excessive reaming during repair.

Consequence:
The influx of hot gases can cause significant carbon deposits in the area of the stem guide. The valve becomes stiff and fails to close properly, with overheating of the seat occurring as a result (burns or shot channels).

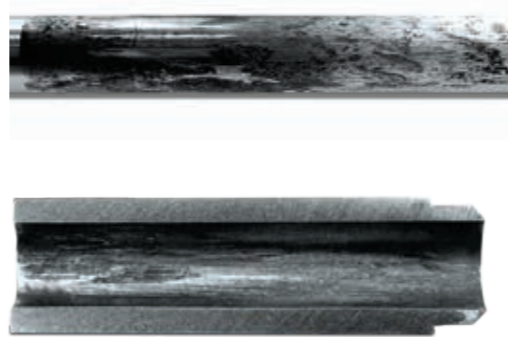
Insufficient valve guide clearance

Cause:
The guide diameter has been dimensioned too small during replacement of the valve guides.

Consequence:
Inadequate lubrication, stiffness and seizures of the valve stem in the guide. Consequential damage such as overheating of the valve head or seat area can occur.

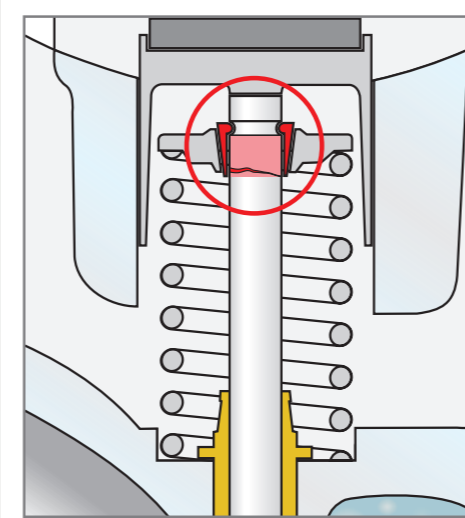
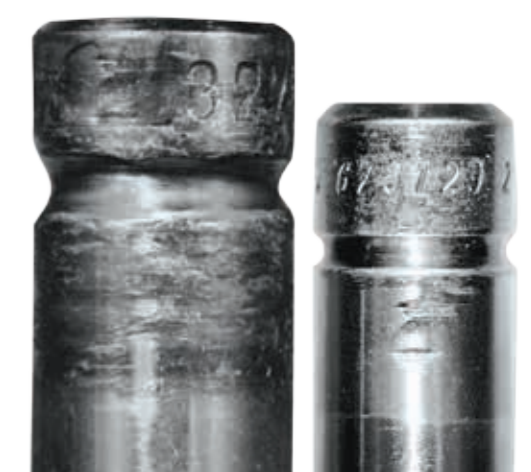
Use of worn valve crotters

Cause:
Old, worn valve crotters were used during replacement of the valves.

Consequence:
If worn valve crotters are reused, the clamping system can become loose during operation. This results in frictional corrosion on the stem and weakening of the valve in this area. This can cause vibration fatigue failure.

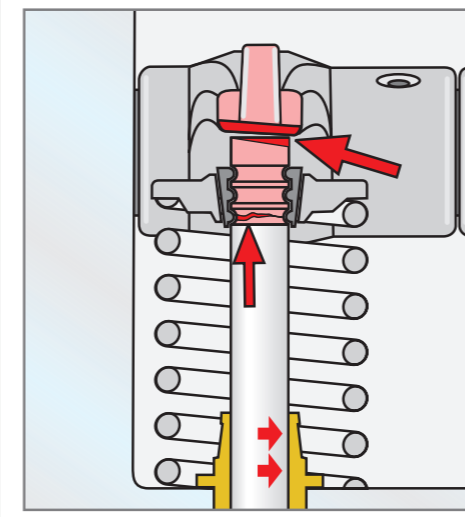
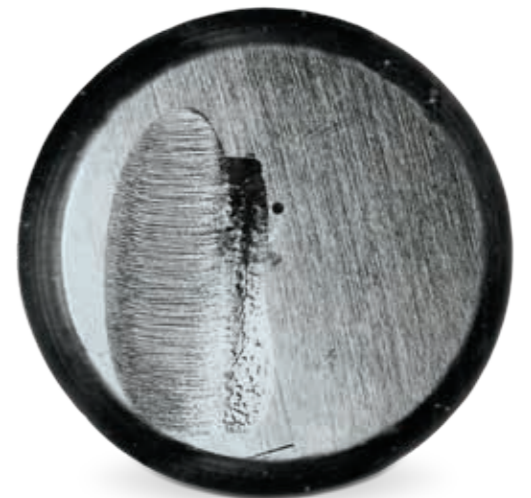
Installing damaged rocker arms/finger type rockers

Cause:
Forces are applied eccentrically from the rocker arm to the skirt end face of the valve.

Consequence:
Unilateral wear occurs on the stem and the skirt end. The lateral force on the valve stem caused by the eccentric application of force causes fatigue fractures in the area of the clamping system.

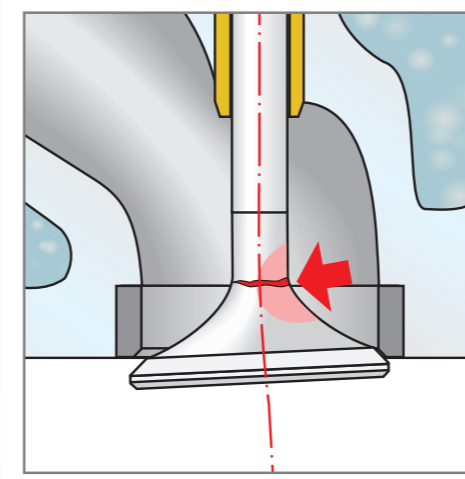
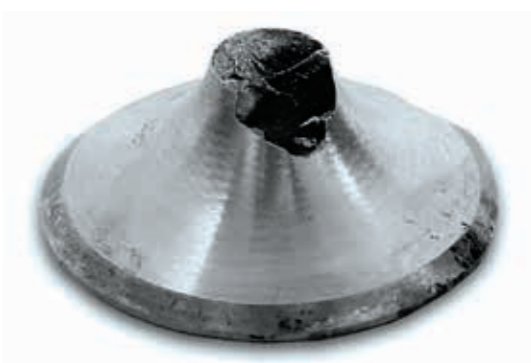
Installing bent valves

Cause:
A bent valve stem will cause unilateral support of the valve seat on the seating ring.

Consequence:
The unilateral stress causes alternating bending stresses and fatigue fractures in the fillet radius at the transition to the stem.

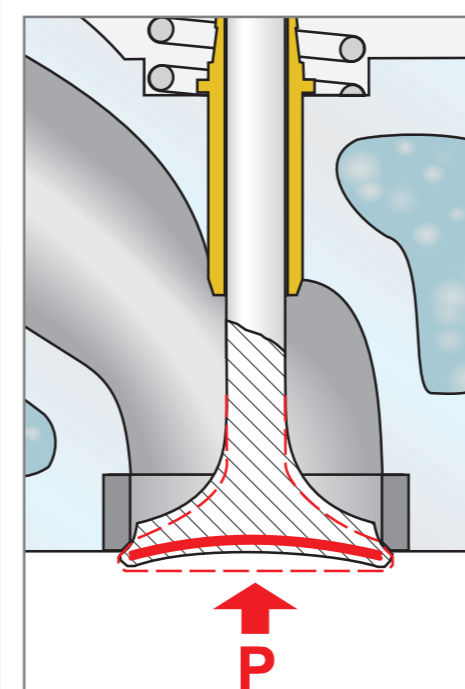
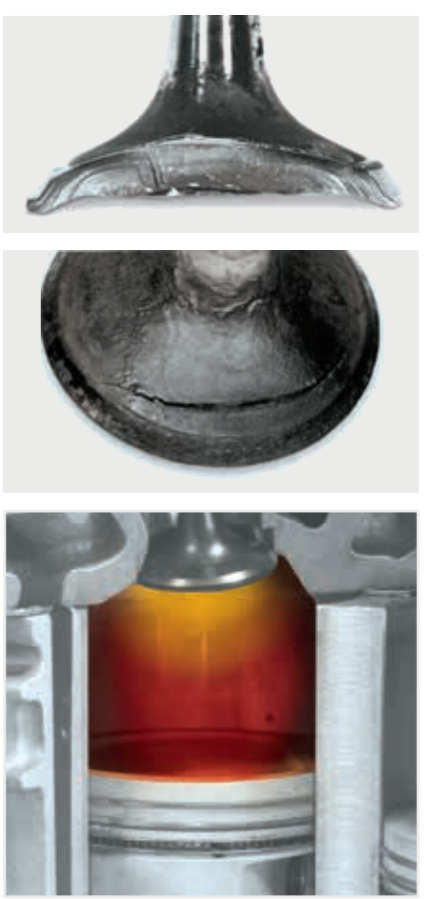
Valve overstressing due to combustion defaults

Cause:
Significant increased pressure and temperature loads occur in the combustion chamber as a result of combustion defaults.

Consequence:
The valve head cannot withstand the high thermo-mechanical loads and bends inwards. This results in so-called tulip formation and causes fractures in the area of the valve head.
