An Astra lacking power

A 2003 Opel Astra 1.7DTI was lacking power, and the customer had been told that the engine ECU was suspected of being faulty, as it wasn't switching the boost control solenoid. Seamus Ryan of Ryans Automotive recounts how the true cause of the problem was easily determined and fixed.

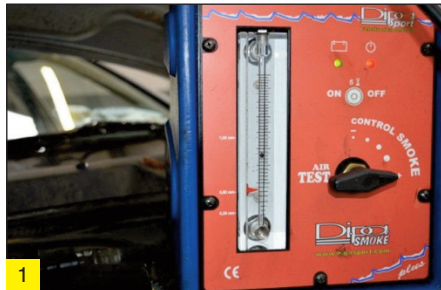
system. But on this Astra, no leaks were seen, and the flow meter on the smoke machine see (fig. 1) showed the system was tight. This proved that the EGR valve was making a good seal. If the EGR valve was stuck open, there would not have been any visible smoke from the intake system, but the flow meter would be high because of smoke escaping out the exhaust.

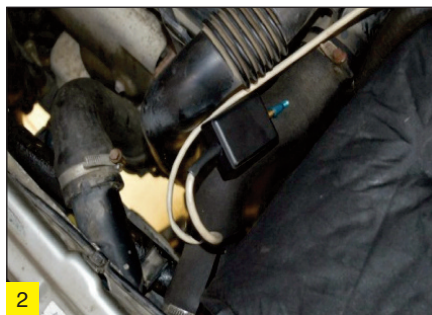
The next step was to check the actual boost pressure with a digital turbo pressure tester. As there was nowhere to tap into the turbo system on this car, a small needle was inserted into the rubber turbo pipe. The needle was inserted in the direction of air flow (fig 2) through the pipe so that after the needle is removed, the turbo pressure closes the hole made by the needle, eliminating any risk of

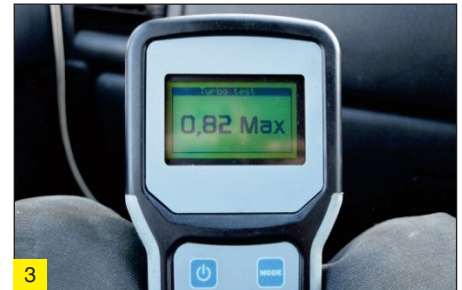
causing a leak in the system. The pressure tester showed that the maximum turbo boost reached was 820 mbar (fig 3) meaning that the turbo was actually generating 1820 mbar within the system. This proved that the turbo was working as it should, and that the problem

was most likely a sensor not reading the existing pressure correctly.

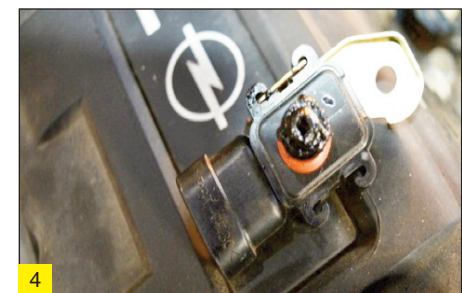
Because the turbo was developing much higher boost than shown on the diagnostic tool, and therefore the ECU, the next step was to remove and examine the turbo boost pressure sensor. The problem became instantly obvious on inspection (fig 4). The turbo boost pressure sensor was badly blocked with carbon, as was the intake manifold. On cleaning the manifold and replacing the boost pressure sensor, full power was restored to the car.
