Not a fun Carnival

When a Kia Carnival's Antilock Brake System (ABS) light came on at speeds greater than 110kph, the problem seemed easy to fix. It was, but only when the proper tools were used to diagnose the problem. A.D.S explains the proper steps needed to find and fix this fault.

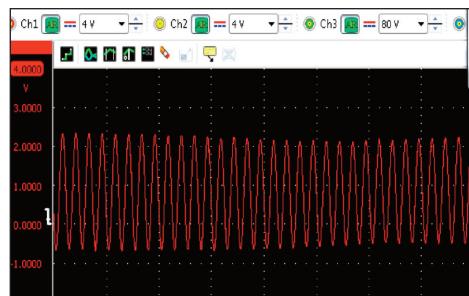
Picture 1 shows the signal of the ABS wheel sensor at 30 kph, and all appears to be normal. The 'peak to peak' value of this alternating current is approximately 3 volts. Typical for this signal is an offset. The signal is not alternating around 0 volts, but at about 0.8 volts. An offset voltage is used so that the Electronic Control Module (ECM) can better recognize a short-circuit fault in the sensor wiring. The offset can be measured with a multimeter when the wheel is not rotating. At higher speeds, the problem became very apparent, as shown in picture 2.

Figure 1: The ABS wheel sensor signal at 30 Kph looked to be perfectly normal

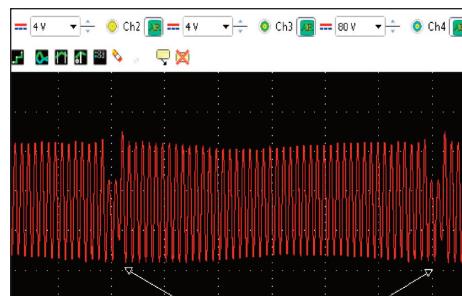
The oscilloscope trace showed two strange anomalies in the signal. Since these anomalies appear in a fixed pattern, it could not have been an electronic fault, so it was mechanical. The repetition was caused by particular teeth on the ABS disk teeth when they passed in front of the sensor. The signal also showed a slight amplitude variation. This is not uncommon, and is caused by the fact that the ABS disk is not perfectly round. When the disk was examined the problem was obvious, some of the teeth on the sensor wheel were physically damaged.

Figure 2: The sensor signal at higher speeds showed an obvious fault, at arrows

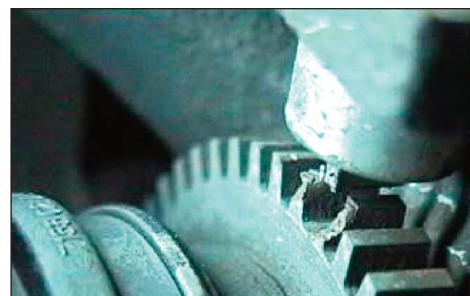
The only question that remained was why the fault was only reported by the ECU at speeds above 110 kph. The scope trace of the wheel speed sensor signal at 110kph showed that the signal amplitude dropped when the broken teeth passed the sensor was even greater than at low speeds. At low speed, the peak to peak amplitude when the broken teeth passed the sensor was 1.5 Volts. At 110 kph the voltage dropped to below 1.0 volt and was great enough for the ECU to recognise the fault. The ABS ECM sets a limit on the voltage of the signal coming from the ABS wheel sensors. This can be a fixed value, where the signal always must be above or under a defined value, but it is also possible that a limit is set dynamically and depends on the speed of the car. So it can be that at a lower speeds, the limits are less strict then at a high speed.

Figure 3: Defective teeth on the ABS disk were good enough for lower speeds

The ATS 5004D oscilloscope showed more information about the wheel speed sensor signal than could be seen with a multimeter. The irregularities in the sensor signal as shown by the scope were very apparent. The irregularities were rhythmic, not random, leaving only a mechanical fault as the problem. The damaged wheel speed disk was replaced and the ABS system was returned to a fully functional state. Without an oscilloscope, the cause of the fault would have been much harder to determine.
