Investigations on a BMW X5 CAN Bus system

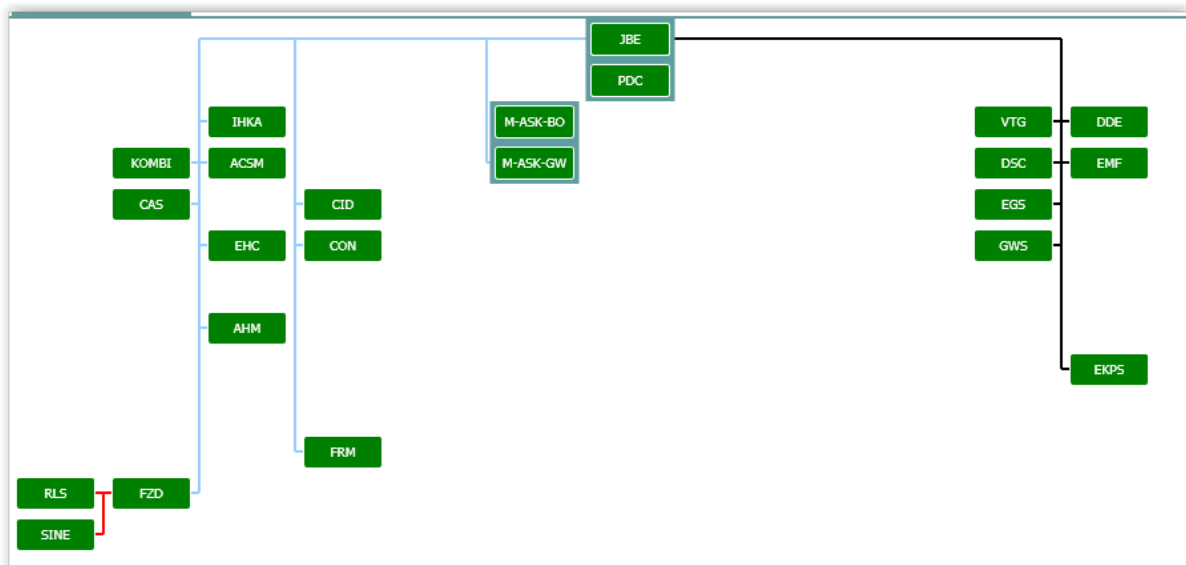
The latter, MOST, is a fibre optic communication system that controls the media devices on the vehicle. By checking which control units we had no communications with, I could easily see that our problem was on the K-Can. I have listed here the control units on this X5's K-Can. Also see figure 2 with the blue lines

- JBE (Junction box Electronics)
- FRM(Football Module)
- CAS (Car Access System)
- CON (iDrive controller)
- CID (Central Information Display)
- EHC (Electronic Height Control)
- KOMBI (Instruments Cluster)
- PDC (Park Distance Control)
- FZD (Roof Control Panel)
- MASK (Radio Head Unit)
- IHKA (Air Conditioning Control Unit)

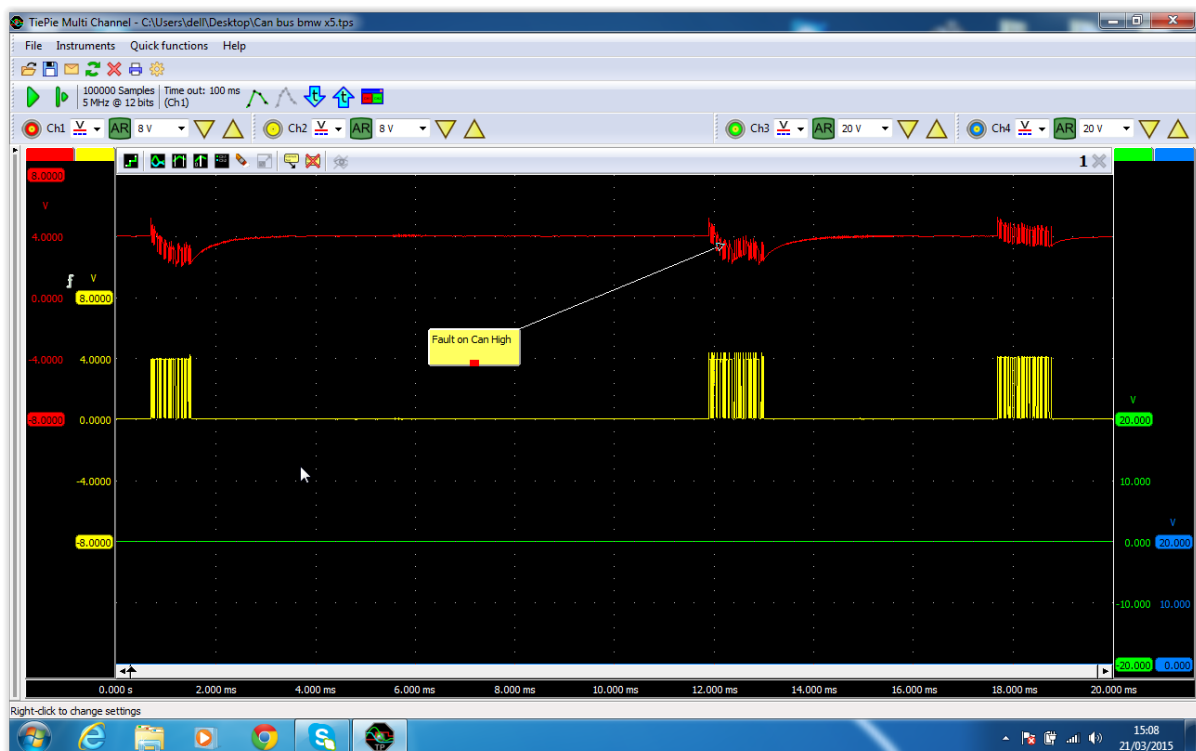
The next step was to get a look at the K-CAN signal on the oscilloscope. The easiest point to connect our scope is at the PDC control unit in the rear right of the boot. As you can see from the picture (Figure1 below) there was not a complete loss of CAN signal but instead a distorted CAN low signal to this control unit.

Unfortunately, in this case the signal was still distorted no matter what unit was disconnected, leaving only a wiring fault as the root cause of the problem. I started to conduct continuity tests on the CAN wires between each control unit. A high resistance was found on the CAN Low wire going from the CAS Unit (under the dashboard) to the EHC (in the boot). When the floor mat was lifted,

there was a dampness on the underneath of the mat and a corroded wire as found in the loom. It turned out that a leaking wiper washer pipe that travels underneath the mat had been the cause of the entire problem. Because the car had been dormant for a year the loom was in a damp environment for an extended period and eventually caused corrosion in the loom.
