Belt tensioner

for
Mercedes Benz CDI engines
ref. no. 611 200 04 70

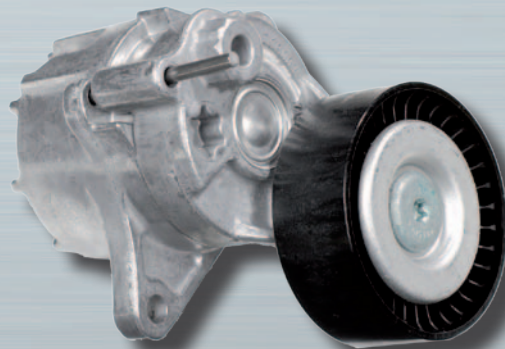
ref. no. 611 200 04 70

For design reasons, when the vehicle is driven with the original version of the belt tensioner installed (ref. no. 611 200 04 70), noise may occur. (The manufacturer has now replaced this version.)

The noise is generated because the spring is too long and makes direct contact with the base of the housing (1). Only the spring's torsional characteristics are important for this application (2), (6).

The noise is caused when the spring touches the cast-in hollow pin (3) and the base of the housing (4).
