# **Connecting rod**

VW Sharan (ref. no. 7M3 411 371C) Seat Alhambra (ref. no. 7M3 411 317C) Ford Galaxy (ref. no. 1 361 653)

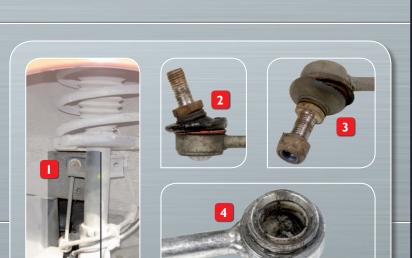
The parts cause noise whilst driving.

Due to its design and location (refer to picture 1) the connecting rod is subject to strong external forces. Both joints are completely exposed to water spraying up from wet roads. A damaged rubber boot (refer to picture 2 and 3), i.e. damaged by road debris, makes it easier for water and dirt to find its way into the joints. Consequently the protective grease will be washed out and the ball pin oxidises. As a result of this, the roughened ball surface increases wear to the plastic ball cup (refer to picture 4), which leads to the joint moving around and causing noise.

#### Rubber bellows (refer to picture 5):

- High performance rubber compound ensures the required flexibility
- Shaped to seal the joint system at each angle
- Proven grease resistance

The locking rings are specifically designed for this application, in order to support the sealing characteristics of the rubber boot

- Use of high performance grease for the ideal lubrication of the ball cup (refer to picture 7) and the ball pin
- Corrosion protection for the whole system
