Chain tensioner

fits
BMW E87 116i with
N45 115 PS / 85 KW engines

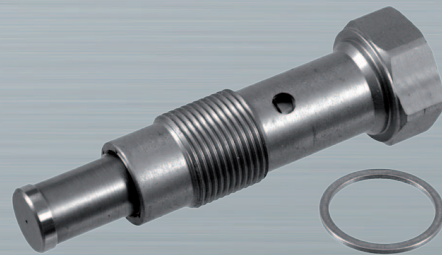
**1****OLD**

The original version (repl. No 11 31 1 439 851) of the chain tensioner has a larger hole above the thread (see Fig. 1). The car manufacturer fitted this version of the chain tensioner in the vehicles referred to above. The result is that the chain can jump under unfavourable loads. In the worst case, valves and pistons come into contact with each other - resulting in engine damage. This version has been replaced by the car manufacturer and is no longer in use.
