## Chain tensioner

fits  
Opel 2.0l turbo and 2.2l petrol engines

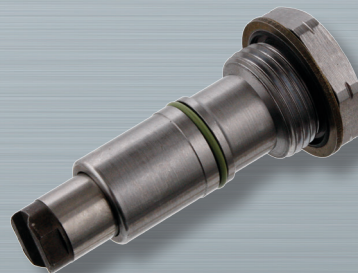
**1**

A blocked timing chain tensioner. The original version (repl. no. 0636549) of the chain tensioner had a green O-ring and a rubber-lined washer (see Fig. 1). The vehicle manufacturer fitted this version in the engines mentioned above. A modified chain tensioner has been used in production since model year 2009.

**OLD****2**

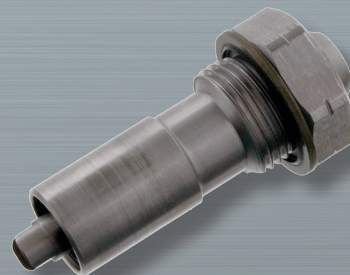
**NEW**

**SWAG no. 40 93 3044**  
repl. no 4807 839

SWAG recommends using only the new chain tensioner SWAG 40 93 3044 (repl. no. 4807 839). This is provided with a rubber-lined metal washer under the head (see Fig. 2). This ensures perfect guidance of the timing chain.
