Checks to complete when fitting 821340 on Citroen and Peugeot applications.

When fitting clutch kit 821340, special attention should be given to the surrounding components to ensure no clutch actuation faults occur.

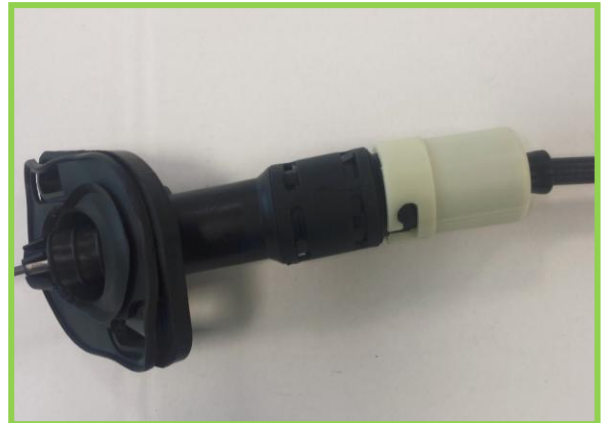
Removing the Retaining Cap

The clutch cable should come with a white plastic retaining cap. Please do not remove the cap until the pedal and the gearbox ends of the cable have been fitted correctly and the cable is located in its correct position. VALEO recommend the use of PSA cable reference 2150EF.

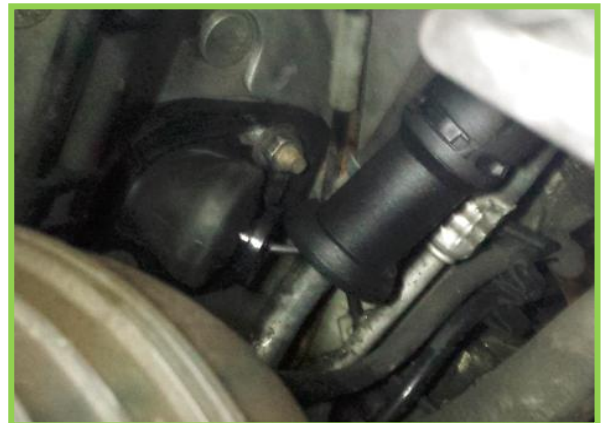
Correctly Fitting the Cable

Feed the cable through the bulkhead towards the pedal box ensuring that there are no bends in the cable and the automatic adjust is sat flush against the end cap. Failure to do this may damage the automatic adjustment mechanism and can over strain the cable as seen in the opposite image.

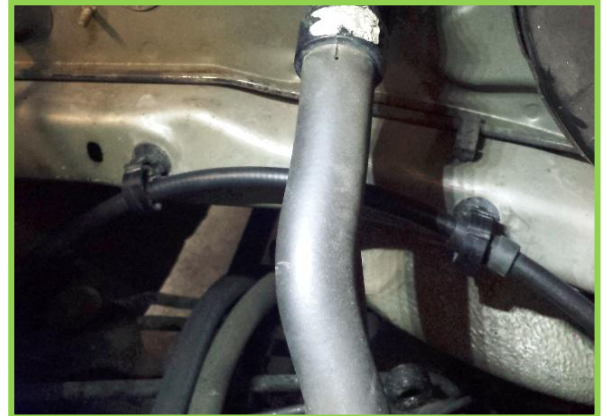
Correctly Fitting the Cable

Ensure that the cable is fed along the firewall and is securely located into the cables retaining clips.

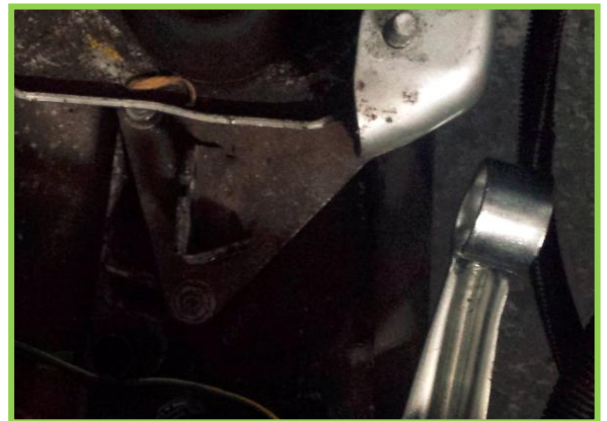
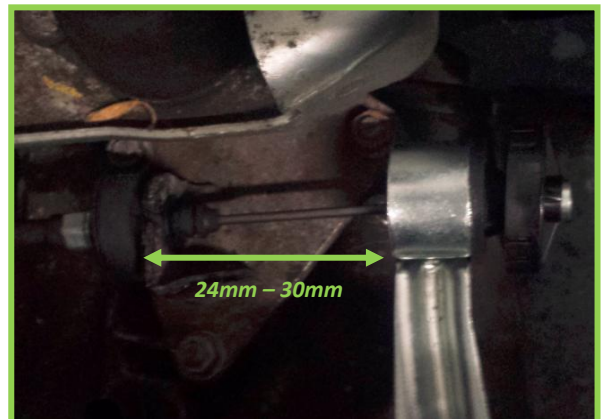
Correct Actuation Fitment

The cable should measure between 24mm and 30mm

1. Fit the cable to the bulk head, ensuring the rubber is correctly located in the tube.
2. Connect the cable to the clutch pedal.
3. Fit the opposite end of the cable into the clutch actuation lever and gearbox bracket.
4. With the aid of a colleague depress the clutch pedal until the locking collar can be removed.
5. Operate the clutch pedal a couple of times to allow the automatic adjuster to set its position.
6. With the clutch pedal depressed, measure the distance between the gearbox bracket and the actuator arm. The measurement should be between 24mm and 30mm, any less will cause over travel of the release bearing, and any more will cause an incomplete lift of the diaphragm.
7. If the measurement cannot be achieved purchase another cable as this may be a result of a faulty automatic adjuster.

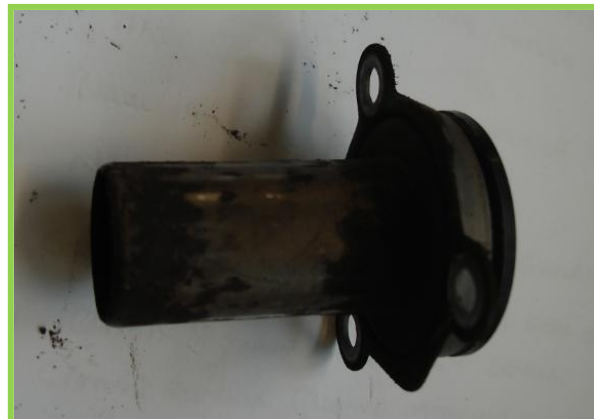
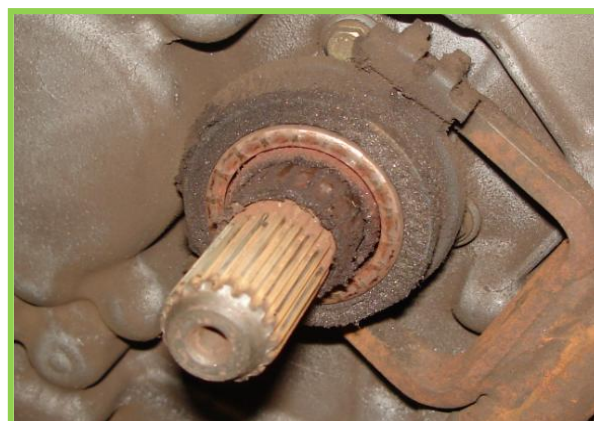
Replacing the Guide Tube

On this vehicle it should be common practice to ensure the **Guide Tube** is replaced every time the clutch assembly is replaced. The wear on the guide tube and the build up of dust and contamination limits the free movement of the bearing and arm and will result in a clearing issue.

There is also a high risk of gear oil being deposited onto the new clutch if the seal is worn or damaged. The guide tube needs to be replaced otherwise this may create excessive, premature preload wear to the pressure plate fingers, causing difficulty in gear selection / clutch judder issues etc.

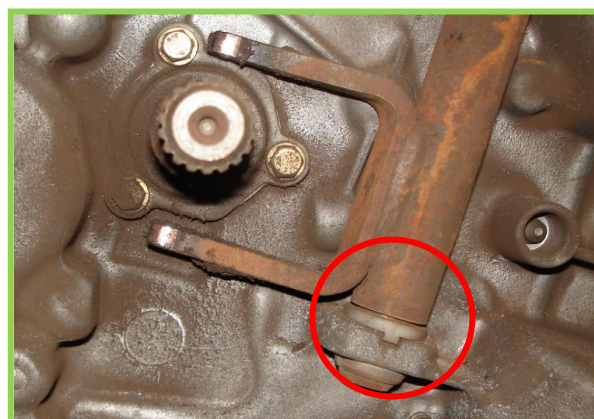
Checking the Release Arm Bearings

It is also recommended that the clutch release arm bushes (bottom release arm bushes circled in red) be checked for wear and if necessary be replaced. Before fitting the clutch fork arm into the upper and lower bushes, lubricate the arm with grease specified by the manufacturer.

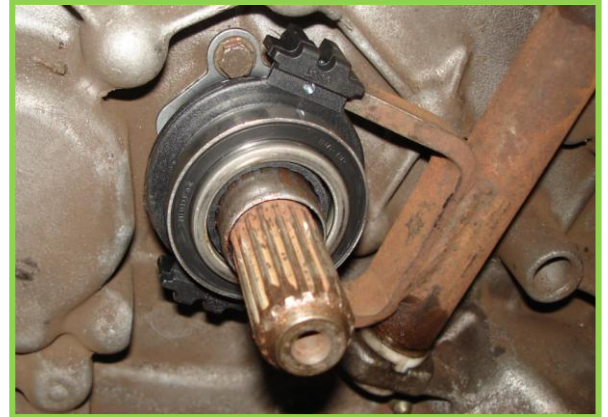
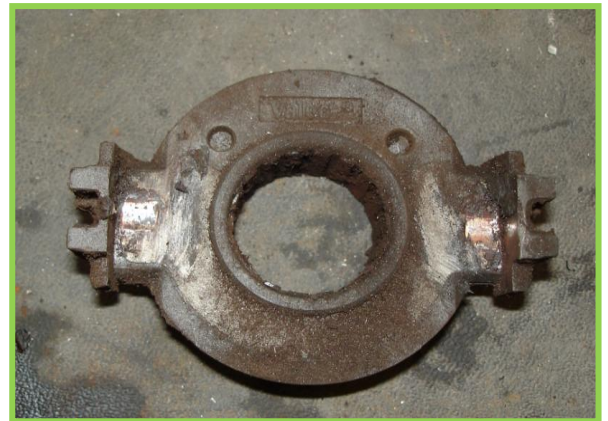
Checking the Release Mechanism

When fitting the clutch release bearing rotate the clutch fork to its highest position and mount the bearing over the guide tube carefully. Rotate the clutch fork arm backwards towards the gearbox and slide the bearing under the fork at the same time. If you carry out the procedure this way it won't break off the **small retaining clips on the bearing**. It is possible to inadvertently move the actuating arm forward whilst trying to get the input shaft of the transmission to line up with the clutch. If the lever is moved forward enough, it will misalign the bearing on the Guide Tube and will not be correctly positioned on the clutch fork. This will be visible on the bearing and will result in preload on the pressure plate fingers. Be careful not to move the lever prior to installation. If this is done it may require the gearbox be lowered from the vehicle and the release bearing be realigned.

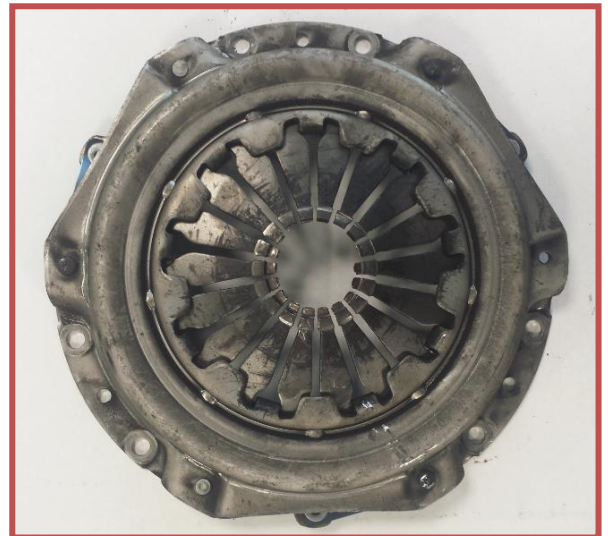
Clutch Preload

Failure to perform the checks detailed in this technical bulletin may result in the vehicle being unable to take up drive and/or having difficulty in selecting gears.

Once removed, excessive wear on the clutch cover fingers are a sure sign that that one of the failures detailed in this technical bulletin have occurred. If units are returned in this condition Valeo Service reserves the right to reject the claim.
