Contaminated gear shift hydraulic unit

Part Number: 828118, 836047, 810009, 837322

For Vehicle: Peugeot 3008, Semi auto, Engine code DV6C (9HR)

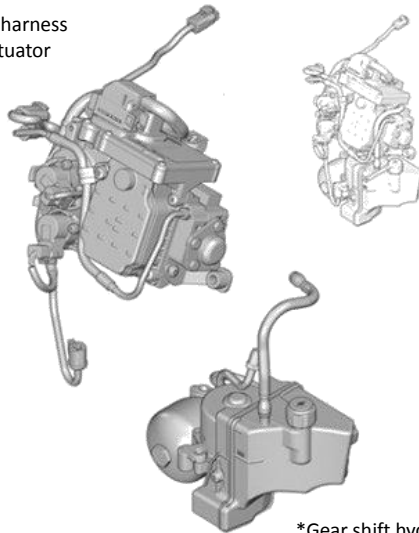
After further investigation, Valeo technicians have identified the cause to be (often when the fault code P1755 or P1712 is present) a contaminant build up in the gear shift hydraulic unit.

*Electric-hydraulic interface harness
and the gearbox ECU and actuator

Valeo recommend the hydraulic unit is inspected according to the vehicle manufacturer's specifications during each clutch change and replaced if necessary. If contamination has occurred the source of the contamination would need to be rectified to prevent future occurrence.
