# Previous Technical Bulletins

## CL 033 Clutch Centring Tool

## IG 002 Replacing Ignition Coil 245104

## AC 010 A/C Loop Flush After Compressor Failure

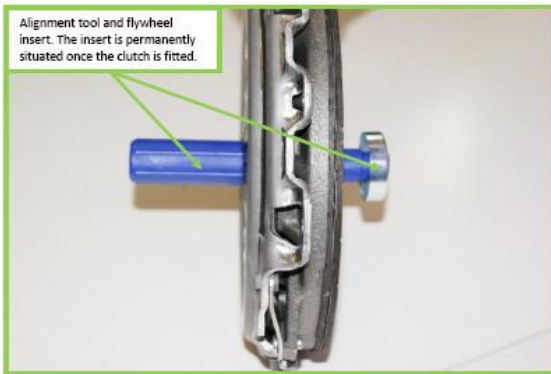
The alignment tools supplied are the centring rod and a metal flywheel insert. The metal insert is a support and is designed to be placed in the centre of the flywheel. The centring rod is then aligned through the clutch cover and friction plate and locates into the metal insert in the flywheel. The insert is not designed to be removed once the clutch is fitted and will not affect the performance and lifetime of the clutch.

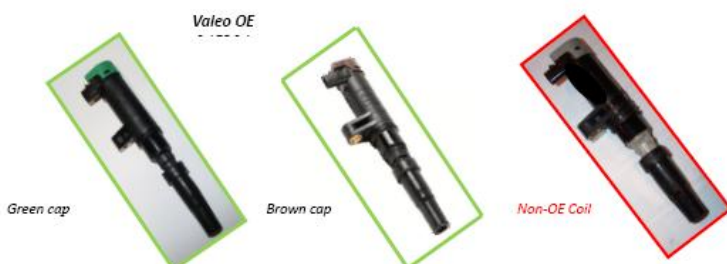
245104 is an OE part designed and fitted to ensure optimum reliability and performance. The Valeo OE part will have either a green or brown cap at the top of the coil. If the coil does not have a green or brown cap, it is likely that it is not an OE part and we would not recommend interchanging as this may cause poor running and loss of performance.

Valeo recommend the following components on the high tension (HT) circuit are replaced to ensure maximum reliability and efficiency of the vehicle. HT leads, spark plugs and if single coil is being replaced the remaining coils should also be replaced.
