# Previous Technical Bulletins

## CL 037 Signs worn DMF causes clutch failure

## CL 038 Damaged splines on clutch friction plate

## PE 001 Sensors not detecting/too sensitive

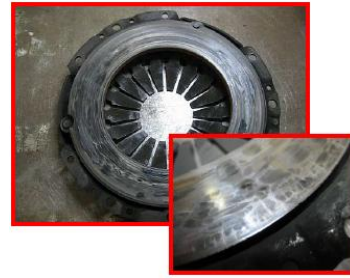
### - Markings on the pressure plate (Top Right)

On the clutch pressure plate there will be radial markings with equally spaced “spots” on the surface. This is due to the dampening effect of the flywheel becoming insufficient, causing the drive plate to “judder” against the pressure plate and producing heat spots.

### - Damage to the hub splines (Bottom Left)

The hub splines on the friction plate will have worn either to a point, to a saw tooth pattern or, in extreme cases, been worn away or the hub has broken up. This is due to the DMF rotational dampening becoming ineffective and allowing the undampened “shocks”, caused by the engine against the resistance of the gearbox, to erode the drive plate splines. If the axial movement of the DMF is outside the specified tolerances, this will also cause wear on the drive plate splines and can cause the hub to detach from the drive plate.

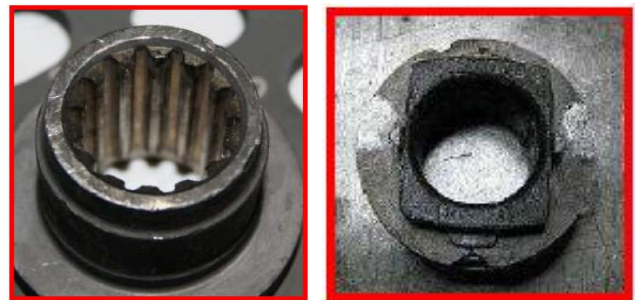
### - Markings on the release bearing (Bottom Right)

Where the release bearing is located on the release fork, there are wide “shuffling” marks and there is no wear on the release mechanism. This has resulted from excessive rotational movement of the worn DMF, causing the cover to oscillate and produce a high amount of acceleration and deceleration through the bearing.
