## Replacement of the wiring loom

Part Number: 698364, 698330, 698281

For vehicle: Renault Applications

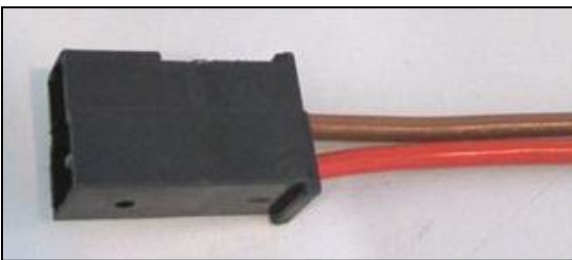
*Old connector*

The Valeo Service Technical department have received several calls stating that an additional loom has been supplied with the blower motor but customers are unsure if it is required. Blower motors 698364, 698330 and 698281 have been modified and the original connector must be removed and replaced by the connector provided within the box.
