Reverse light not functioning due to control unit failure

Part Number: 044075 and 044076

For Vehicle: Seat Leon 2005-2012

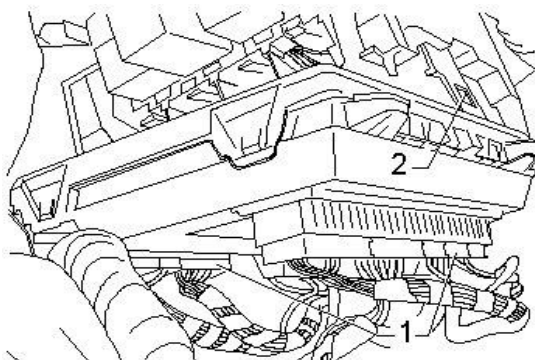
After investigating the issue Valeo technicians have identified that the lights are not at fault and the symptom described above is caused by a faulty on-board network control unit (J519).

- 1) Select reverse gear and using a multimeter check the output voltage.
- 2) If there is no voltage you need to replace the faulty on-board network control unit J519. To do this remove the driver side foot well cover. As illustrated in the diagram below, lift tab 2 and remove the on board control unit (BSG) from its support. Unplug connector 1.

- 3) Reprogram the faulty on-board network control unit (J519) to ensure compatibility with the new lights.
