Similar, but **not the same**

eXponentia's Steve Carter tackles a Fiat that refused to start a replacement engine, thought to be identical to the failed engine. But sometimes things are not as they appear to be, and only knowledge and good diagnostics will get you to a happy ending.

Steve Carter, eXponentia

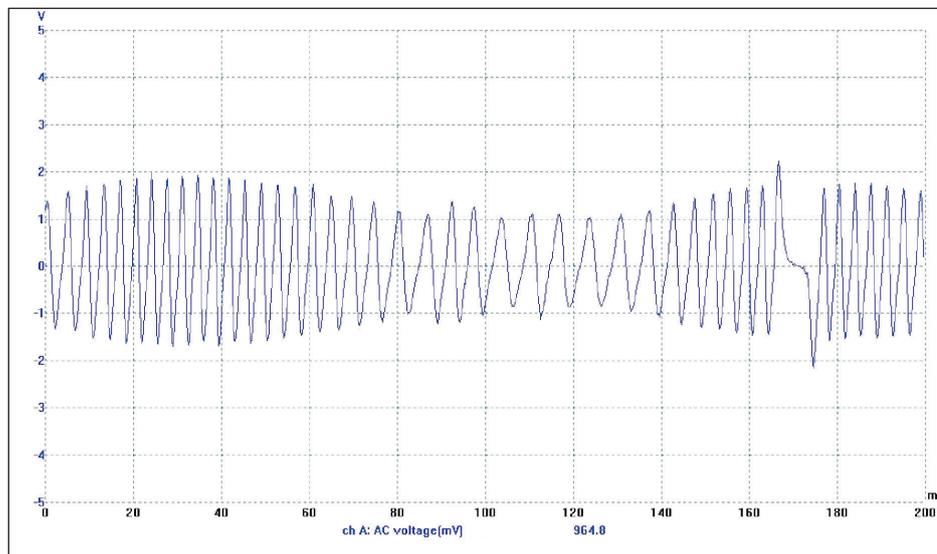
As you can see in the scope trace image, the output of the sensor is just too low, with the maximum peak-to-peak being just below 2 volts, where in reality there should be at least 4 volts, if not 6. This was obviously the reason why the vehicle would not start and was the reason for those extreme RPM readings on live data. This engine was supplied in good working order from a reputable supplier. On further discussions with the garage, it transpired that although this was the same engine, it had been fitted to a different gearbox, and they were still using the original gearbox.

On further investigation, it became clear that although the engines were nearly identical, they had one main difference - the flywheel. If the engine had been used in conjunction with its original gearbox, then this problem would never have arisen. But they had used it with the vehicle's original gearbox, which had a slightly different fixing/profile for the crankshaft position sensor. This resulted in the sensor being just under 2 mm further away from the flywheel, resulting in the erratic RPM reading and scope trace.

The scope trace of the crankshaft sensor signal showed it was too low, as well as erratic.

The solution to this problem was to exchange the flywheels. As you can see from this, more diligence and understanding of your diagnostic readings is paramount for modern common-rail diesel engines.
