# Trouble codes - lost in translation

An older model Mercedes that ran well failed the NCT on excessive emissions. The trouble code was less than straight forward in its attempt to explain the cause of the fault. A bit of good diagnostics and testing found the problem.

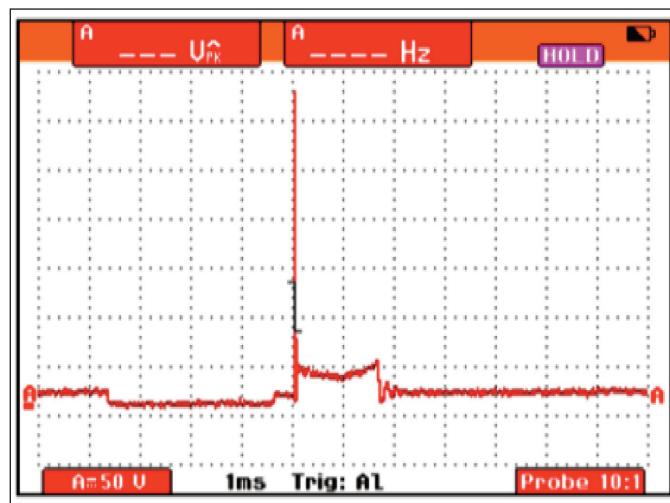
As you can see in figure 1, there was a textbook primary wave pattern on two of the coils. Just prior to the firing line you can see the current limiting hump, indicating that the coil had become fully charged, and that the engine ECM had in fact stopped charging this particular coil.

Two of the coils in the Mercedes were perfect, as can be seen in this textbook coil primary trace.

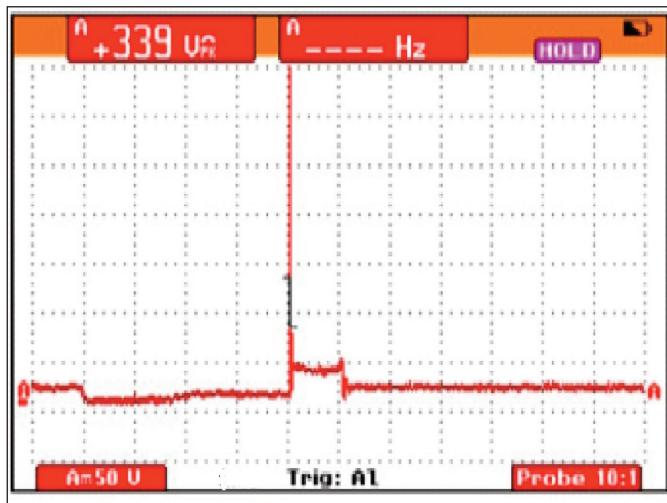
In figure 2, circumstances are much different. You can see straight away that

there is no current limiting hump. In fact, 2 ms into the coil charging time, the engine ECM stopped charging this coil, or what was more likely happening was that the insulation on this coil was breaking down. The breakdown of the coil insulation created an earth path, and prevented this one coil from charging properly. Also note that the burn time was only half the time of the other two coils, and that there are no coil oscillations indicating a very discharged coil. The faulty coil was replaced, the code was cleared and the emissions returned to normal.

Figure 2. One of the coils in the Mercedes was obviously faulty, the result of a short to earth through the coil insulation.
