# A trio of Puzzling cars

Three cars put eXponentia's Steve Carter through his diagnostic paces, but all is not as it seems. Sometimes the real problem is beyond the ability of the ECU to understand, other than to say that something is wrong. That's where knowledge comes in.

In this troubleshooting guide we will be looking at three vehicles from different manufacturers, all with their own unique problems.

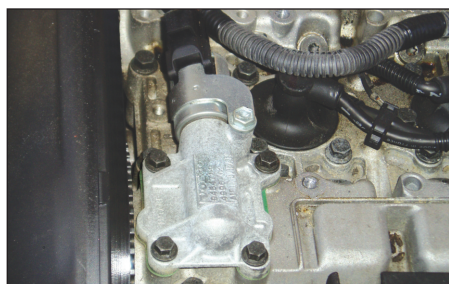
On closer inspection of the actuator, significant amounts of solidified engine oil deposits could be seen in the galleries within the actuator. These deposits were cleaned out with a degreasing agent, and the problem was resolved.

**A build-up of oil deposits had intermittently interfered with the variable valve timing**

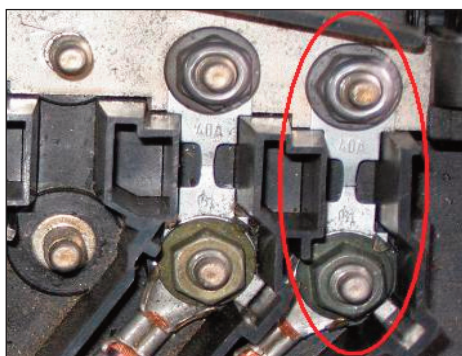
You probably remember that some of this vehicle's fuses are housed within the plastic battery cover and these fuses are just thin metal strips between two bolt fixings. A blown fuse can be seen very clearly, but in our case, the fuse had actually cracked and looked more like a scratch than a defective fuse. The fuse was replaced and the ABS was completely functional again.

**A crack in a strip fuse, circled, can cause an intermittent fault. An observant eye will also suspect that the other strip fuse in this example needs to be replaced as well.**
