# A needle in a haystack

eXponentia gets to grips with the Controller Area Network (CAN) Bus system and figures out an intermittent fault on a 2007 Citroen C8 climate control system.

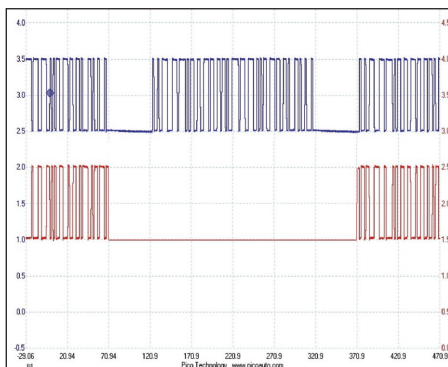
**The scope trace of the climate control circuit showed an intermittent fault, but only when the damaged wire was manipulated**

Initially the scope trace remained the same, then from nowhere, we briefly saw a scope trace which indicated an open circuit on the CAN circuit. No sooner had we seen this, the scope trace returned to normal. For a further 10 minutes we could not replicate this fault, until I moved my foot and the fault returned momentarily.

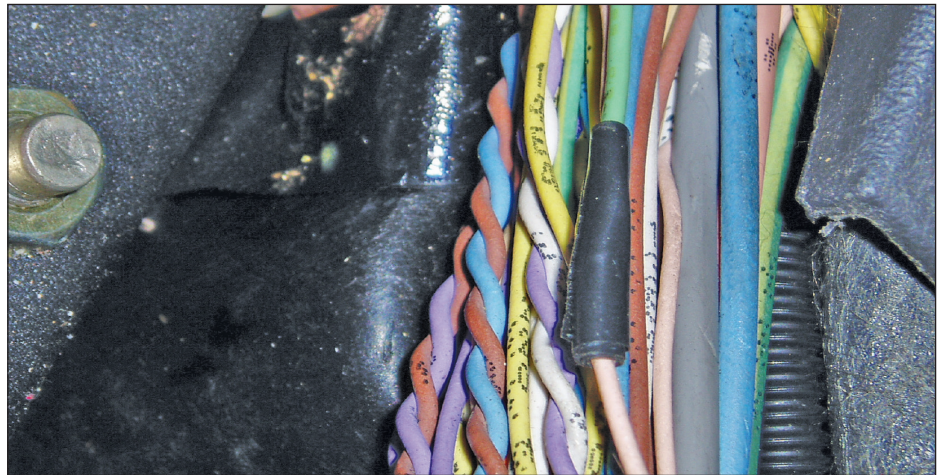
**The cause of the intermittent fault: a partially cut wire that would only act up when the driver put their foot on a plate that covered the wiring loom**

On closer examination, under the rubber car mat there was a hard plastic removable plate covering the vehicle's car battery. Once the plate was removed, it could be seen that one of the wires had become trapped and was partially cut. Although the wire was not completely cut through, there was sufficient damage to the wire that caused an intermittent fault whenever the driver placed their foot on top of the cover.
