Equalisation charge for a Hybrid

Hybrids are here to stay, and they are going to thrive under a combination of more stringent emission requirements and rising fuel costs. eXponentia's Steve Carter recounts a problem encountered on a Prius that refused to start and then required an equalisation charge to clear a fault code.

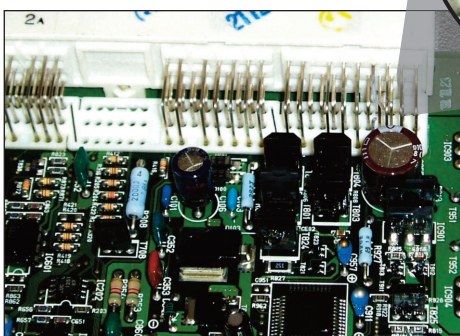
control module and the second indicating a problem with the vehicle's traction battery. After gaining access to the engine ECM, located in the passenger foot well, some scorch marks on the ECM loom connector were detected. We took the decision to open the module and from the picture below, you can clearly see the fault. We were fairly confident this fault was caused by incorrect jumpstarting of this vehicle. On repairing this connection, and with a fully charged 12V supply, the vehicle started promptly.
