febi 176483, 176525

various Audi and Volkswagen models
with the V6 TDi engine

Intake manifold with swirl flap actuator and gasket

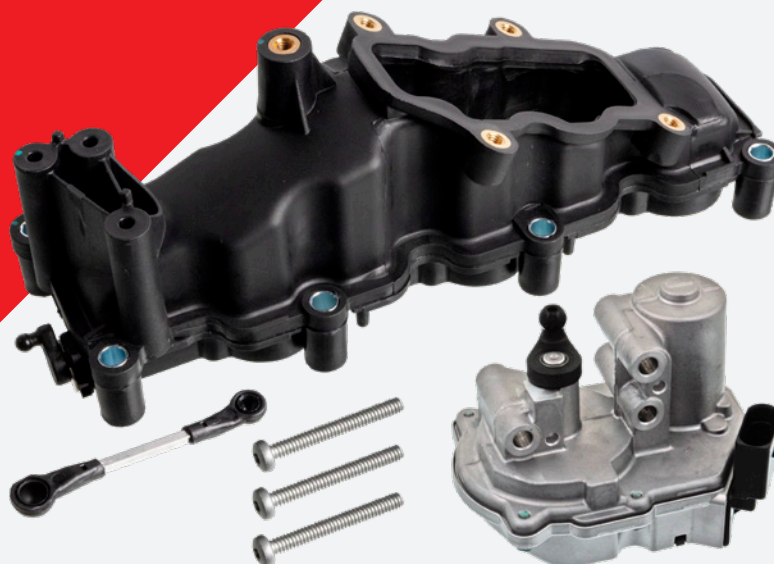
The engine performance and drivability is poor, and the engine warning lamp is illuminated.

Excess carbon build-up in the inlet manifold prevents the swirl flaps from opening or closing completely. This puts unnecessary strain on the linkage and actuator, leading to a broken or worn linkage. As a result, the actuator operates out of its designed tolerances and the following fault code is logged in the engine control unit: P2015 - intake manifold flap position/signal improbable.

For this repair, febi provides a combined kit containing the inlet manifold, gasket and swirl flap adjustment motor and linkage for each manifold. Following the successful completion of the replacement, the swirl flap system has a 'learning' procedure take place - for this, a suitable diagnostic tool is required.
