# febi Highlight

## Ball Joint ProKit

febi no. 28355/38490

Fits: Citroën C5, C6 /  
Peugeot 407, 508

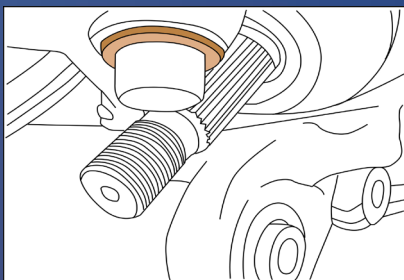
Problems may arise when replacing these ball joints. During the removal of the failed ball joint it is common for the inner race to remain attached to the wheel hub (See Figure 1&2). This then causes fitment problems when the new febi ball joint (28355 or 38490) is fitted. It is imperative to ensure that the full ball joint including the inner race is fully removed from the wheel hub.

Figure 1: Inner Race still attached to Hub

The hub must be thoroughly cleaned before fitting the new febi ball joint ProKit which comes with a protection cap to help stop future water ingress.

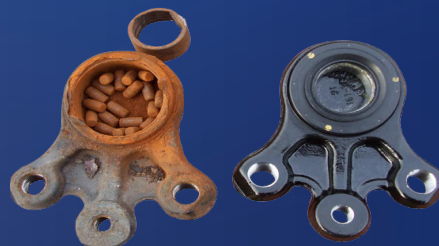
Figure 2: Ball Joint with & without Inner Race
