febi Tip

e.g. with the febi suspension arm for the Audi A 4 front axle

febi no. 11350

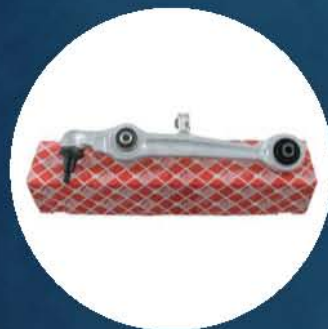
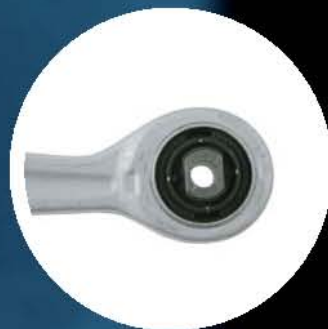
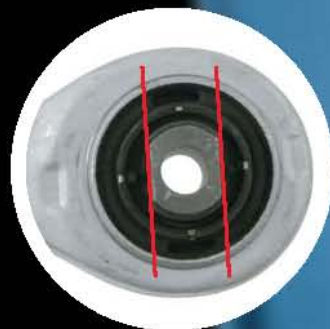
Make sure to tighten the fastening screws of the exchanged suspension arm in the deflected state in any case to avoid complaints. The tightening of the screws in the rebound state is a serious assembly error that results in an overload of the rubber bearings. This may lead to cracks that result in the premature failure of the rubber bearing. The axle geometry changes and causes additional costs (increased tyre wear!).

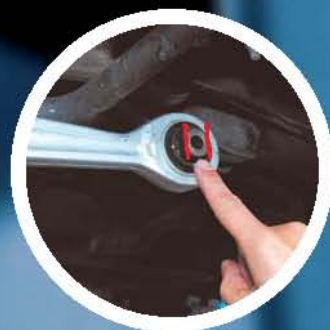
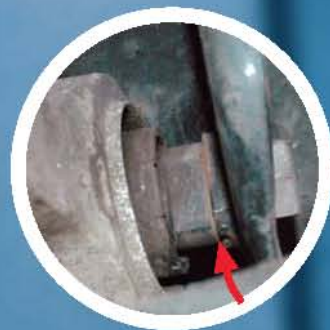
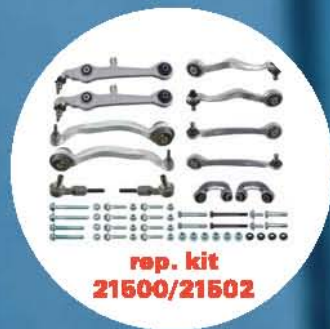
Therefore, some febi suspension arms provide of a rubber bearing where the installation position is identified by a marking:

The marking of the suspension arm and the countermarking on the drive assembly carrier must match. Then, your customer is on the safe side!
