febi 44493

Ford C-Max II, Focus III, Grand C-Max II, Transit II Connect

Engine: 1.0 EcoBoost

Engine Mounting

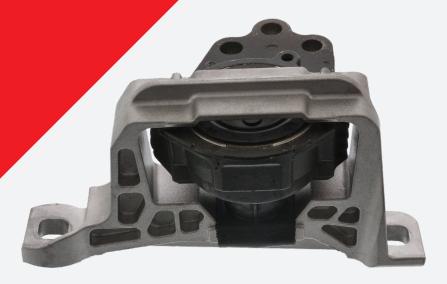
When the engine is idling, a whining, vibrating, humming noise can be heard inside the cabin area.

Exposure to the elements and hot and cold heat cycles leads to the degradation of the rubber component of this hydraulic engine mounting. This results in the hydraulic fluid seeping out, causing excessive movement of the engine mounting.

Confirm the vibration is being caused by the engine mounting. This can be done by increasing the engine speed to see if the noise goes or changes tone.

Using an assistant, manipulate the mounting by adding pressure to it with a lever bar and applying a load to the engine mounting in several areas. If the noise goes or hydraulic oil can be seen leaking, the mounting should be replaced.

Due to the excess movement caused by this failing engine mounting, it can cause stress to the lower engine mounting leading to it becoming weak. febi replacement part 45855 is also available if required.

Therefore, it is recommended that when diagnosing engine mountings all are checked.
