**febi 36626**
**38444, 38450, 38851**

FWD Ford Transit, Tourneo

Engine 2.2-litre TDCI Duratorq

## Crankshaft Pulley

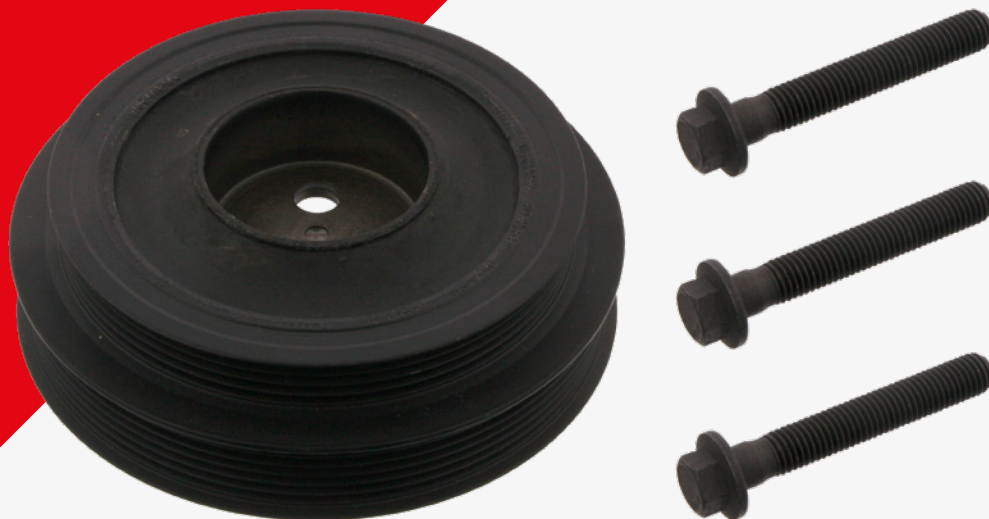
Typical problems include: Abnormal noise and vibration from the timing belt area; Alternator warning lamp illuminated; Power steering belt damaged or has come off the pulley.

Over time, water and road debris ingress into the torsional vibration damper crankshaft pulley, causing premature wear and the failure of the crankshaft pulley and auxiliary drive belt system.

Replace the crankshaft pulley with febi Prokit 36626 which includes all of the necessary bolts. All damaged or worn auxiliary drive belts should also be replaced.
