# febi 36634 109394, 173133

Various Volkswagen, Audi, Seat and Skoda models fitted with the 1.6 and 2.0-litre TDi engine.

## Oil Filter, Oil Filter Cap, Oil Filter Housing

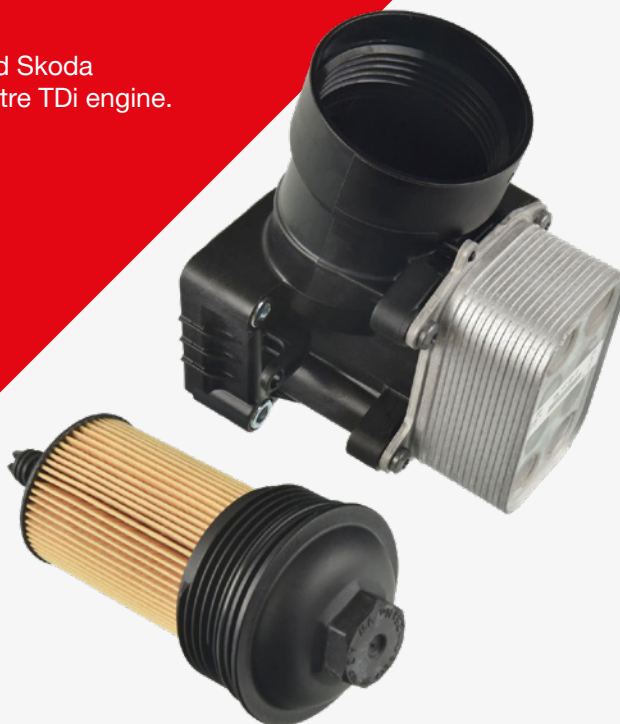
Oil leaking from the engine oil filter housing.

The oil filter cap and housing, which is made from a hard and durable thermoplastic, becomes weak or damaged following repeated unscrewing and tightening. This is most likely to occur if the cap is not correctly aligned, or is over tightened, during the filter element replacement.

When replacing oil filter 36634, inspect the cap and housing for any distortion or damage to the threads. If there is any damage found, replace the cap with 173133 or the complete housing 109394, where necessary.

When replacing and fitting the new filter element, coat the new "O" ring seals (fitted to the cap) with clean engine oil. Insert the cap and filter assembly into the housing and, in a clockwise direction, screw in; tightening to 25 Nm as illustrated on the cap. Fill the engine to the correct level with fresh oil. Following this, start the engine and check for any oil leaks.
