to fit:  
Renault Clio 3

## Wiper motor

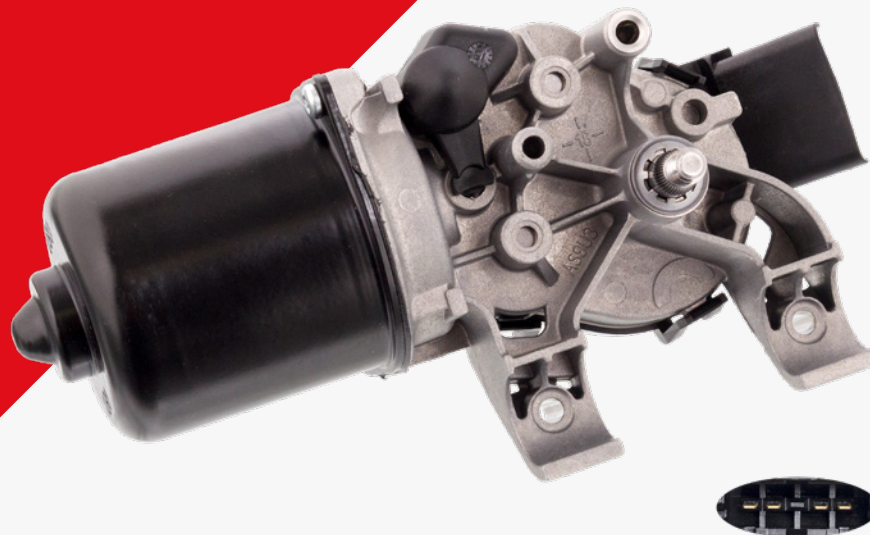
The wiper motor is submerged in rainwater and fails due to water ingress.

Over time, road debris and fallen leaves can block the water drain tubes in the scuttle panel below the front windscreen. This causes the area to fill with rainwater - submerging the wiper motor and linkage. This constant immersion in water gradually leads to the penetration of the casing and, ultimately, to motor failure.

Remove the faulty wiper motor and linkage. Clean out the drain tubes using a suitable piece of wire and flush through - with water - to make sure that the one-way valve (rubber flap) is clean and not sticking. Check the wiring loom connector is free from corrosion; clean or replace as necessary.

Before replacing the wiper motor, check that the wiper linkage is in good working condition and has not seized, or has any excess 'play' in the joints. If found to be seized or sufficiently 'worn', replace the linkage as well as the faulty wiper motor.
